## General Information

<b>Make</b>	Toyota	<b>Model</b>	Hiace
<b>YOM</b>	2025	<b>Odo Meter Reading</b>	3
<b>Registration No.</b>	DA667B	<b>Chassis No.</b>	JTFPA9AP7S8055276
<b>CC</b>	2.8	<b>Transmission</b>	M/T
<b>Fuel Type</b>	Diesel	<b>Type of Body</b>	Van
<b>Colour</b>	White

## Body / Panel Condition

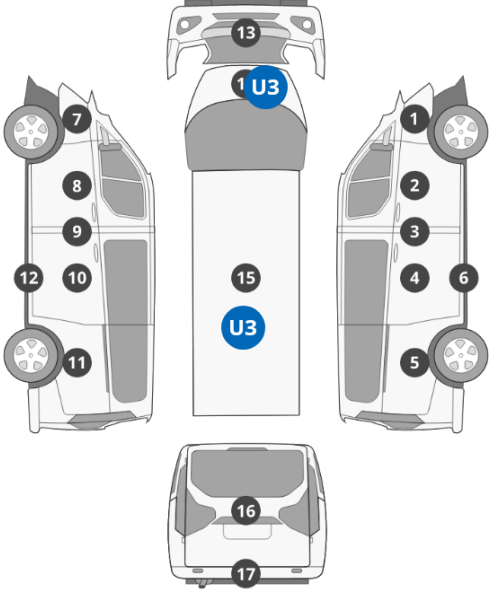
<p><b>A</b> : Scratch <b>AU</b> : Scratch &amp; Dent <b>B</b> : Modified <b>C</b> : Corrosion <b>G</b> : Stone chip <b>P</b> : Faded <b>S</b> : Rust <b>SC</b> : Rust &amp; Corrosion <b>U</b> : Dent <b>X</b> : Defective <b>Y</b> : Crack, Gap</p>
<b>Remarks</b> Defects not found	<b>Remarks</b> Bonnet, Headlight - Dent - Medium / Roof - Dent - Medium
<b>Frame Evaluation :</b> <span style="color: red; font-weight: bold; font-size: 1.2em;">A</span>	<b>Functional Evaluation :</b> <span style="color: red; font-weight: bold; font-size: 1.2em;">A</span>

<b>Inspector Notes</b>
cluster of dents on roof and hood.
