General Information

Make	Suzuki	Model	Carry
YOM	2023	Odo Meter Reading	31,412
Registration No.	NIS8569	Chassis No.	MHYDC61TOPJ214474
CC	1.5	Transmission	M/T
Fuel Type	Gas	Type of Body	Van
Colour	White

Body / Panel Condition

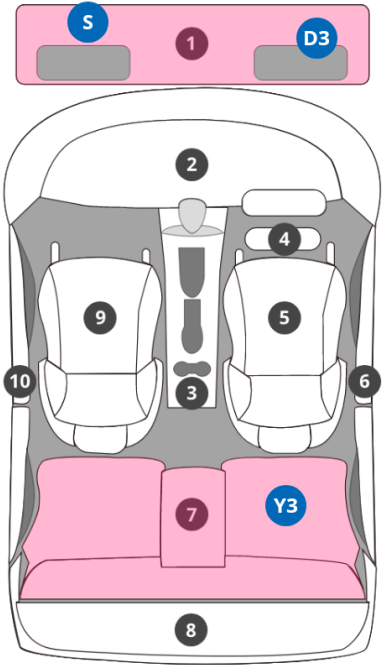
Interior Evaluation : C	Exterior Evaluation : D

<p>A : Scratch AU : Scratch & Dent B : Modified C : Corrosion G : Stone chip P : Faded S : Rust SC : Rust & Corrosion U : Dent X : Defective Y : Crack, Gap</p>
<p>Remarks Overall Interior - Worn as per age - Yes / Overall Interior - Smell - Yes / Ceiling - Crinkle - Medium / Rear Seat - Grime - Medium</p>	<p>Remarks Front Panel - Repair Traces - Yes / (L) Rear Corner Panel - Repair Traces - Yes / (L) Side Gate - Repair mark - Yes / Front Panel - Repair mark - Yes / (L) Side Gate - Scratch - Small / (L) Front Door, Molding - Scratch - Small / Front Bumper, Grille, Lamps - Scratch - Small / Rear Gate - Rust, Corrosion - Large / Roof - Scratch & Dent - Medium / (R) Side Gate - Scratch - Small / (R) Front Door, Molding - Scratch - Small / (R) Front Fender, Molding - Scratch - Minimal / Front Windshield - Damaged - Large</p>
