General Information

Make	Suzuki	Model	Carry
YOM	2024	Odo Meter Reading	19,319
Registration No.	NKC5903	Chassis No.	MHYDC61T7RJ212014
CC	1.5	Transmission	M/T
Fuel Type	Gas	Type of Body	Van
Colour	White

Body / Panel Condition

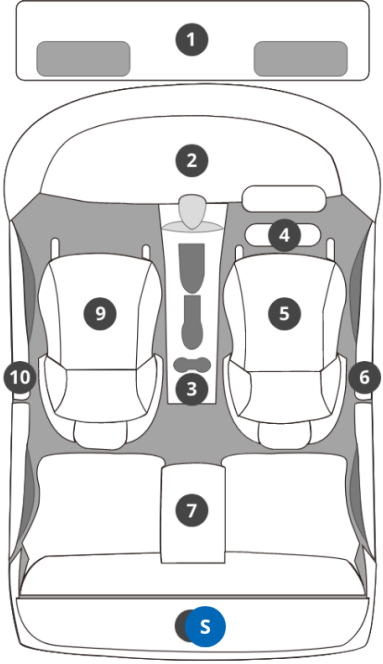
Interior Evaluation : C	Exterior Evaluation : C

<p>a : Cut, Fray d : Loose, Deformed k : Animal Hair s : Smell t : Cigarette Burns x : Defective y : Stain</p>

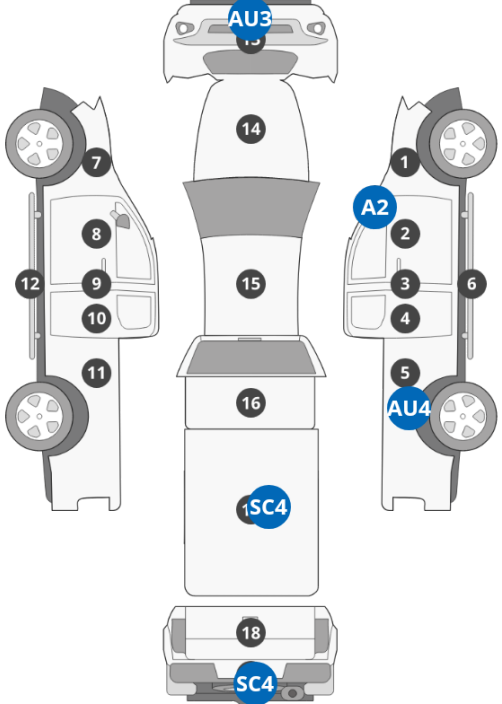
<p>A : Scratch AU : Scratch & Dent B : Modified C : Corrosion G : Stone chip P : Faded S : Rust SC : Rust & Corrosion U : Dent X : Defective Y : Crack, Gap</p>
<p>Remarks Overall Interior - Smell - Yes / Overall Interior - Worn as per age - Yes</p>	<p>Remarks (L) Rear Corner Panel - Repair Traces - Yes / (R) Rear Corner Panel - Repair Traces - Yes / (R) Mirror - Scratch - Small / (R) Side Gate - Scratch & Dent - Large / Rear Bumper, Lamps, Panels - Rust, Corrosion - Large / Cargo Bed Floor - Rust, Corrosion - Large / Front Bumper, Grille, Lamps - Scratch & Dent - Medium</p>
Frame Evaluation : B	Functional Evaluation : A
<p>Remarks Center Floor Panel - Bulge (Cuts, Major Deforms) or Corrosion ? - Yes</p>	<p>Remarks Reverse Camera - N/A - Yes</p>

<p>Inspector Notes</p>
<p>no warranty booklet, no jack, no tools, with spare tire, with LTO plate, possible flooding</p>
