General Information

| Make | Toyota | Model | Vios |
| Registration No. | NHR6555 | Chassis No. | PA1B18F37P4230440 |

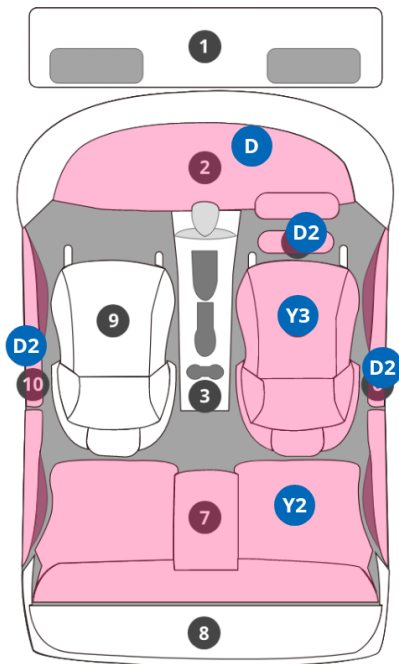
| <p>Remarks (L) Front Floor Mat - Worked - Small / (R) Front Seat - Grime - Medium / Rear Seat - Grime - Small / (L) Front Trim - Worked - Small / (R) Front Trim - Worked - Small / Dashboard - Traces of Adhesive Tape - Yes</p> | <p>Remarks Trunk Hood, Rear Gate - Scratch & Dent - Small / (L) Rear Fender, Molding - Scratch - Small / (L) Rear Door, Molding - Scratch - Small / (L) Front Door, Molding - Scratch - Small / Rear Bumper, Lamps, Panels - Scratch - Small / (R) Mirror - Scratch - Small / Roof - Dent - Small / Bonnet, Headlight - Scratch - Small / Front Bumper, Grille, Lamps - Scratch - Small</p> |
