General Information

| Make | Toyota | Model | Vios |
| YOM | 2024 | Odo Meter Reading | 32,538 |
| Registration No. | NHH6121 | Chassis No. | PA1B18F31R4250475 |

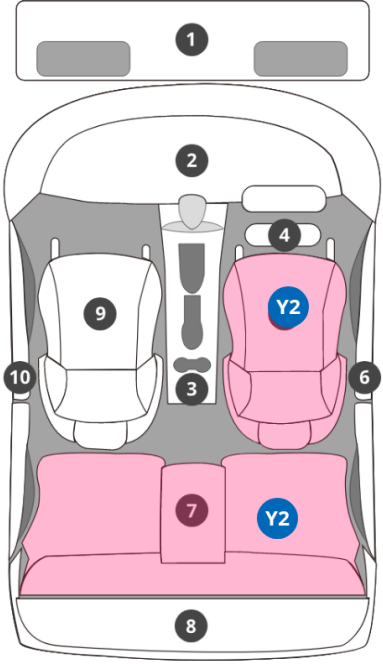
| Interior Evaluation : A | Exterior Evaluation : C |

| <p>Remarks Rear Seat - Grime - Small / (R) Front Seat - Grime - Small</p> | <p>Remarks Bonnet - Repair Traces - Yes / (L) Front Fender - Repair Traces - Yes / (L) Front Fender, Molding - Repair mark - Yes / Bonnet, Headlight - Repair mark - Yes / (L) Front Fender, Molding - Scratch - Small / Trunk Hood, Rear Gate - Scratch - Minimal / Rear Bumper, Lamps, Panels - Scratch - Small / (R) Rear Fender, Molding - Scratch - Small / (R) Rear Door, Molding - Scratch - Small / (R) Front Door, Molding - Scratch - Small / (R) Mirror - Scratch - Small / Front Bumper, Grille, Lamps - Repair mark - Yes / Bonnet, Headlight - Scratch - Small / (L) Front Door, Molding - Scratch - Minimal / (L) Rear Door, Molding - Scratch - Small / (L) Rear Fender, Molding - Scratch - Minimal / Roof - Scratch - Small / Front Bumper, Grille, Lamps - Scratch - Small</p> |
