## General Information

<b>Make</b>	Toyota	<b>Model</b>	Lite Ace
<b>YOM</b>	2023	<b>Odo Meter Reading</b>	12,868
<b>Registration No.</b>	NHE7064	<b>Chassis No.</b>	MHKB3FE10PK002347
<b>CC</b>	1.5	<b>Transmission</b>	M/T
<b>Fuel Type</b>	Gas	<b>Type of Body</b>	Van
<b>Colour</b>	White

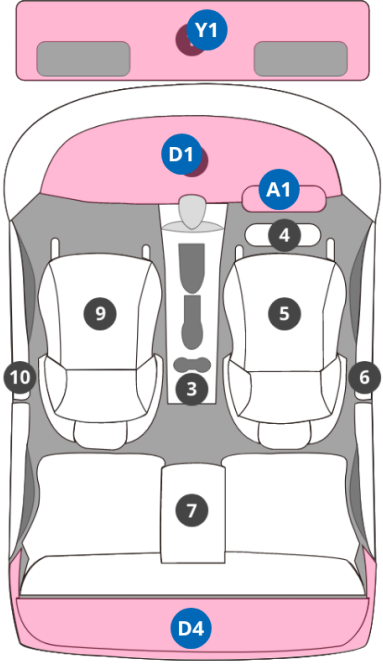
<b>Interior Evaluation :</b> <span style="float: right; color: red; font-weight: bold;">C</span>	<b>Exterior Evaluation :</b> <span style="float: right; color: red; font-weight: bold;">D</span>

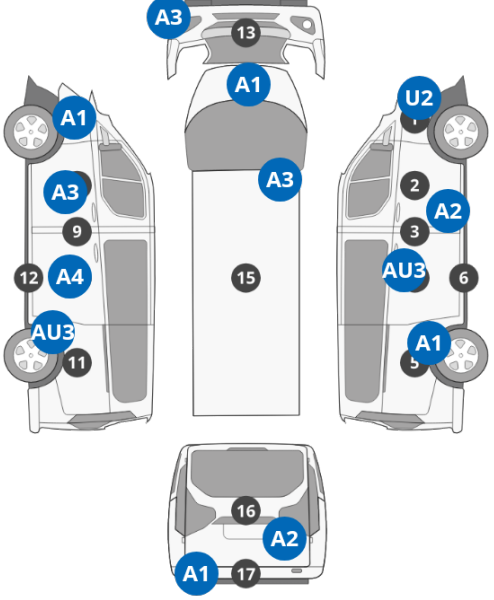
<p><b>A</b> : Scratch <b>AU</b> : Scratch &amp; Dent <b>B</b> : Modified <b>C</b> : Corrosion <b>G</b> : Stone chip <b>P</b> : Faded <b>S</b> : Rust <b>SC</b> : Rust &amp; Corrosion <b>U</b> : Dent <b>X</b> : Defective <b>Y</b> : Crack, Gap</p>
<p><b>Remarks</b> Trunk Room - Worked - Large / Glove Box - Worn, Scratch, Cut, Crack - Minimal / Dashboard - Worked - Minimal / Ceiling - Grime - Minimal</p>	<p><b>Remarks</b> (R) Front Fender, Molding - Dent - Small / (R) Front Door, Molding - Scratch - Small / (R) Rear Door, Molding - Scratch &amp; Dent - Medium / Roof - Scratch - Medium / Trunk Hood, Rear Gate - Scratch - Small / (L) Rear Door, Molding - Scratch - Large / (L) Rear Fender, Molding - Scratch &amp; Dent - Medium / (L) Front Door, Molding - Scratch - Medium / Front Bumper, Grille, Lamps - Scratch - Medium / Front Panel - Scratch - Minimal / (L) Front Fender, Molding - Scratch - Minimal / (R) Rear Fender, Molding - Scratch - Minimal / Rear Bumper, Lamps, Panels - Scratch - Minimal</p>
