## General Information

Make	Toyota	Model	Vios
YOM	2024	Odo Meter Reading	6,055
Registration No.	NHN6657	Chassis No.	PA1B18F32R4249111
CC	1.3	Transmission	CVT
Fuel Type	Gas	Type of Body	Sedan
Colour	Blue

## Body / Panel Condition

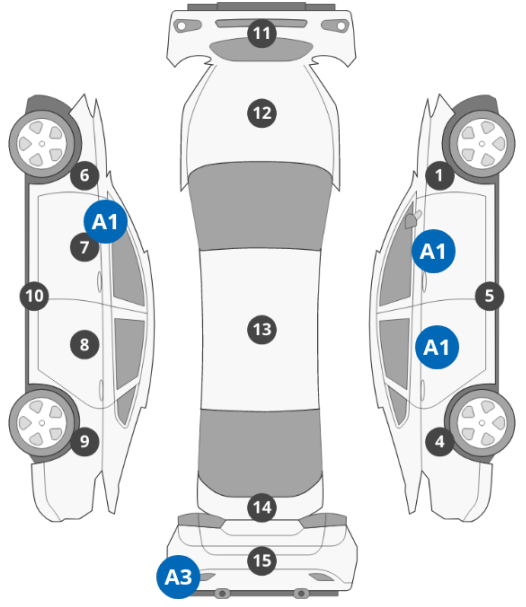
<p><b>A</b> : Scratch <b>AU</b> : Scratch &amp; Dent <b>B</b> : Modified <b>C</b> : Corrosion <b>G</b> : Stone chip <b>P</b> : Faded <b>S</b> : Rust <b>SC</b> : Rust &amp; Corrosion <b>U</b> : Dent <b>X</b> : Defective <b>Y</b> : Crack, Gap</p>
<p><b>Remarks</b> (L) Front Floor Mat - Worked - Small / (L) Front Seat - Worn - Yes</p>	<p><b>Remarks</b> (R) Front Door, Molding - Scratch - Minimal / (R) Rear Door, Molding - Scratch - Minimal / Rear Bumper, Lamps, Panels - Scratch - Medium / (L) Mirror - Scratch - Minimal</p>
<b>Frame Evaluation :</b> <span style="float: right;"><b>A</b></span>	<b>Functional Evaluation :</b> <span style="float: right;"><b>C</b></span>
