## General Information

<b>Make</b>	Mitsubishi	<b>Model</b>	Mirage
<b>YOM</b>	2023	<b>Odo Meter Reading</b>	29,358
<b>Registration No.</b>	NIR4364	<b>Chassis No.</b>	PAEA13TJPPA008610
<b>CC</b>	1.2	<b>Transmission</b>	CVT
<b>Fuel Type</b>	Gas	<b>Type of Body</b>	Sedan
<b>Colour</b>	Gray

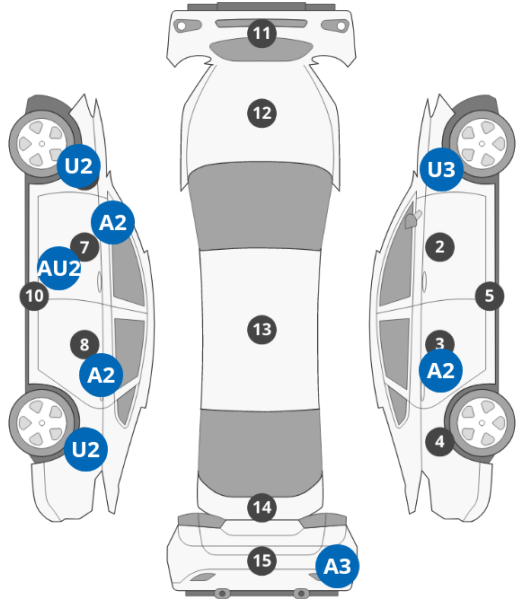
<p><b>A</b> : Scratch <b>AU</b> : Scratch &amp; Dent <b>B</b> : Modified <b>C</b> : Corrosion <b>G</b> : Stone chip <b>P</b> : Faded <b>S</b> : Rust <b>SC</b> : Rust &amp; Corrosion <b>U</b> : Dent <b>X</b> : Defective <b>Y</b> : Crack, Gap</p>
<p><b>Remarks</b> (R) Front Seat - Grime - Medium / Rear Seat - Grime - Medium / Mat Other - Grime - Small / (L) Front Seat - Grime - Medium</p>	<p><b>Remarks</b> (R) Front Fender, Molding - Dent - Medium / (L) Mirror - Scratch - Small / (L) Front Fender, Molding - Dent - Small / (L) Rear Fender, Molding - Dent - Small / (L) Rear Door, Molding - Scratch - Small / (L) Front Door, Molding - Scratch &amp; Dent - Small / Rear Bumper, Lamps, Panels - Scratch - Medium / (R) Rear Door, Molding - Scratch - Small</p>
