General Information

Date & Time: 30, May, 2025 15:08

Make	Hyundai	Model	Eon
YOM	2018	Odo Meter Reading	58,145
Registration No.	NCT6766	Chassis No.	MALA251AAJM572624
CC	0.8	Transmission	M/T
Fuel Type	Gas	Type of Body	Hatchback
Colour	White

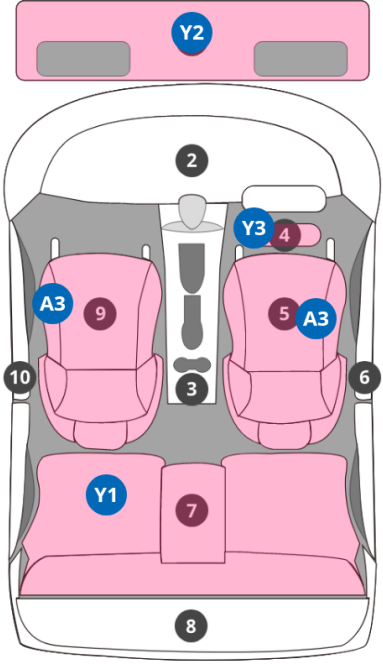
Interior Evaluation : B	Exterior Evaluation : D

<p>A : Scratch AU : Scratch & Dent B : Modified C : Corrosion G : Stone chip P : Faded S : Rust SC : Rust & Corrosion U : Dent X : Defective Y : Crack, Gap</p>
<p>Remarks Ceiling - Grime - Small / (L) Front Seat - Cut, Crack - Medium / (L) Front Floor Mat - Grime - Medium / Rear Seat - Grime - Minimal / (R) Front Seat - Cut, Crack - Medium</p>	<p>Remarks Trunk Hood, Rear Gate - Repair Traces - Yes / Roof - Scratch & Dent - Medium / (L) Mirror - Scratch - Small / Front Bumper, Grille, Lamps - Scratch & Dent - Large / (L) Rear Door, Molding - Scratch - Medium / (R) Mirror - Scratch - Medium / Bonnet, Headlight - Scratch - Medium / (R) Rear Door, Molding - Scratch - Medium / Rear Bumper, Lamps, Panels - Scratch - Medium</p>
Frame Evaluation : A	Functional Evaluation : C

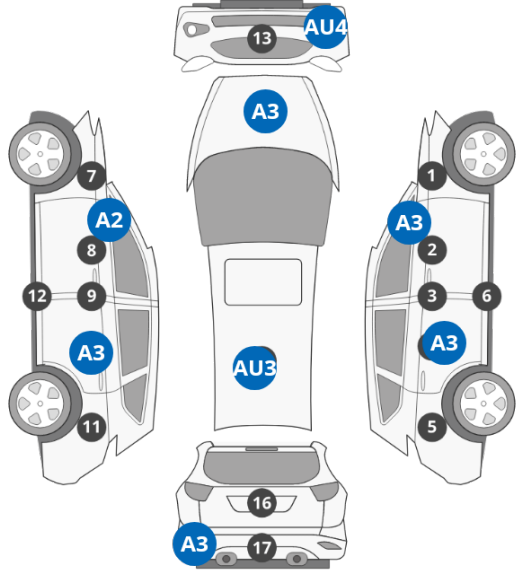
<p>Inspector Notes</p>
<p>Gap at front bumper issue. without warranty booklet, seat cover and tools. With jack and spare tire,. 1 key. with LTO plate</p>
