## General Information

| Make | Toyota | Model | Vios |
| Registration No. | NGT2314 | Chassis No. | PA1B18F31L4132904 |

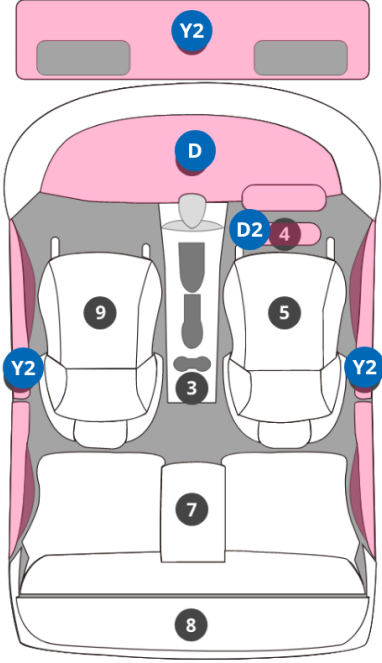
| <p><b>Remarks</b><br/>Ceiling - Grime - Small / (R) Front Trim - Grime - Small / Dashboard - Traces of Adhesive Tape - Yes / (L) Front Floor Mat - Worked - Small / (L) Front Trim - Grime - Small</p> | <p><b>Remarks</b><br/>(R) Front Fender - Repair Traces - Yes / (L) Rear Fender - Repair Traces - Yes / (R) Rear Fender - Repair Traces - Yes / (L) Front Fender, Molding - Scratch - Medium / (L) Mirror - Scratch - Small / (L) Front Door, Molding - Scratch - Large / (L) Rear Door, Molding - Scratch - Small / Front Bumper, Grille, Lamps - Repair mark - Yes / Member (Bolted) - Dent - Yes / Front Bumper, Grille, Lamps - Scratch - Large / (R) Mirror - Scratch - Small / (R) Rear Door, Molding - Scratch &amp; Dent - Small / (R) Front Door, Molding - Scratch - Medium / (R) Rear Wheel, Cover - Cap Missing - Yes / Rear Bumper, Lamps, Panels - Modified - Small / Trunk Hood, Rear Gate - Scratch - Minimal / Bonnet, Headlight - Scratch &amp; Dent - Small</p> |
