## General Information

| Make | Nissan | Model | Navara |
| Registration No. | NCU3065 | Chassis No. | MNTCC2D23Z0036813 |

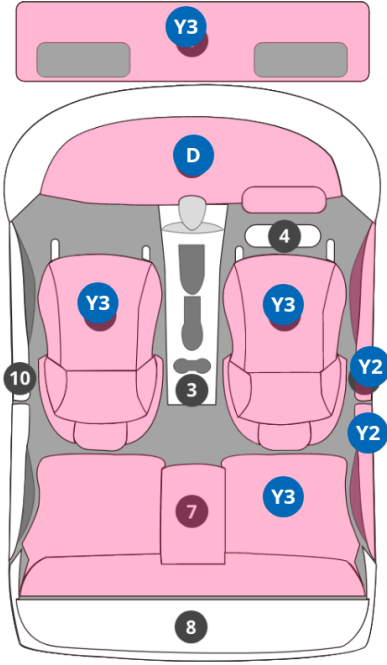
| Interior Evaluation : <span style="color: red;">C</span> | Exterior Evaluation : <span style="color: red;">E</span> |
| <b>Remarks</b><br>Ceiling - Grime - Medium / (R) Front Trim - Grime - Small / (R) Front Seat - Grime - Medium / Rear Seat - Grime - Medium / (R) Rear Trim - Grime - Small / (L) Front Seat - Grime - Medium / Dashboard - Traces of Adhesive Tape - Yes | <b>Remarks</b><br>Rear Gate - Repair mark - Yes / (L) Front Fender, Molding - Repair mark - Yes / (L) Side Gate - Scratch & Dent - Large / (L) Rear Door, Molding - Scratch & Dent - Large / (L) Front Fender, Molding - Scratch - Medium / Bonnet, Headlight - Dent - Small / Front Bumper, Grille, Lamps - Scratch & Dent - Large / (R) Front Fender, Molding - Scratch & Dent - Small / (R) Front Door, Molding - Scratch - Medium / (R) Rear Door, Molding - Repair mark - Yes / (R) Rear Door, Molding - Scratch - Small / (R) Side Gate - Scratch - Large / Rear Bumper, Lamps, Panels - Scratch & Dent - Large / Rear Gate - Scratch - Medium / Cab Back Panel - Scratch & Dent - Large / Roof - Dent - Small |
