## General Information

<b>Make</b>	Toyota	<b>Model</b>	Vios
<b>YOM</b>	2023	<b>Odo Meter Reading</b>	27,142
<b>Registration No.</b>	CBI7780	<b>Chassis No.</b>	PA1B18F3XP4224079
<b>CC</b>	1.3	<b>Transmission</b>	CVT
<b>Fuel Type</b>	Gas	<b>Type of Body</b>	Sedan
<b>Colour</b>	Red

## Body / Panel Condition

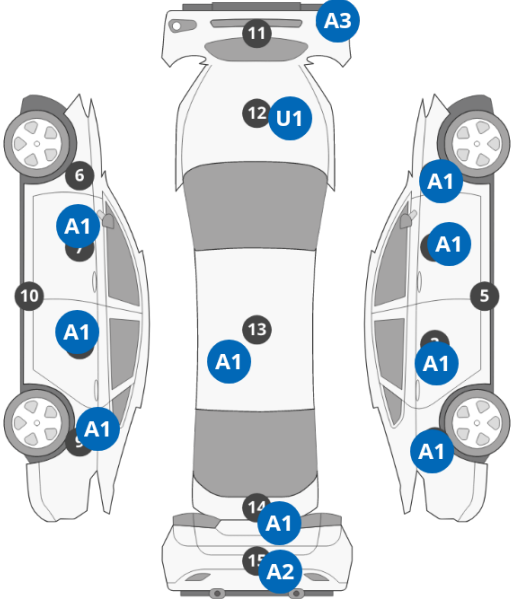
</div> <p><b>A</b> : Scratch <b>AU</b> : Scratch &amp; Dent <b>B</b> : Modified <b>C</b> : Corrosion <b>G</b> : Stone chip <b>P</b> : Faded <b>S</b> : Rust <b>SC</b> : Rust &amp; Corrosion <b>U</b> : Dent <b>X</b> : Defective <b>Y</b> : Crack, Gap</p>
<p><b>Remarks</b> Rear Seat - Grime - Large / (L) Front Seat - Grime - Medium / Trunk Room - Worn, Scratch, Cut, Crack - Minimal / (R) Front Seat - Grime - Large / (R) Front Trim - Worked - Small / (L) Front Trim - Grime - Minimal / Ceiling - Grime - Minimal / Mat Other - Grime - Large</p>	<p><b>Remarks</b> (R) Front Fender, Molding - Scratch - Minimal / (R) Front Door, Molding - Scratch - Minimal / (R) Rear Door, Molding - Scratch - Minimal / (R) Rear Fender, Molding - Scratch - Minimal / Rear Bumper, Lamps, Panels - Scratch - Small / Trunk Hood, Rear Gate - Scratch - Minimal / (L) Rear Fender, Molding - Scratch - Minimal / Roof - Scratch - Minimal / (L) Front Door, Molding - Scratch - Minimal / (L) Rear Door, Molding - Scratch - Minimal / Front Bumper, Grille, Lamps - Scratch - Medium / Bonnet, Headlight - Dent - Minimal</p>
