## General Information

<b>Make</b>	Mitsubishi	<b>Model</b>	Montero SPT
<b>YOM</b>	2022	<b>Odo Meter Reading</b>	84,418
<b>Registration No.</b>	EAF1917	<b>Chassis No.</b>	MMBGJKR10NH012411
<b>CC</b>	2.5	<b>Transmission</b>	M/T
<b>Fuel Type</b>	Diesel	<b>Type of Body</b>	SUV
<b>Colour</b>	Silver

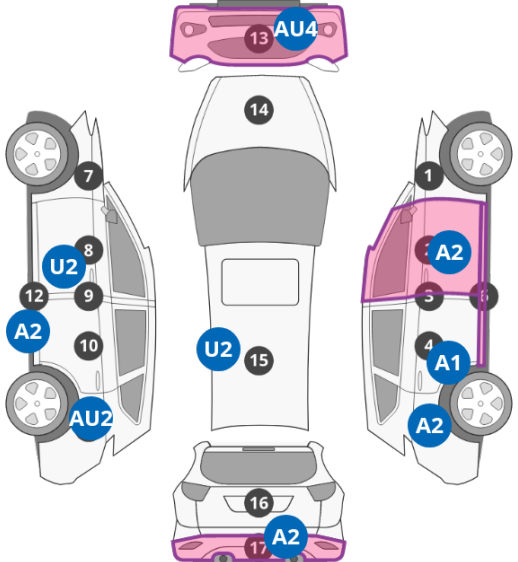
<p><b>A</b> : Scratch <b>AU</b> : Scratch &amp; Dent <b>B</b> : Modified <b>C</b> : Corrosion <b>G</b> : Stone chip <b>P</b> : Faded <b>S</b> : Rust <b>SC</b> : Rust &amp; Corrosion <b>U</b> : Dent <b>X</b> : Defective <b>Y</b> : Crack, Gap</p>
<p><b>Remarks</b> Ceiling - Grime - Medium / (R) Front Trim - Grime - Small / Dashboard - Traces of Adhesive Tape - Yes / (R) Front Seat - Grime - Medium / Rear Seat - Grime - Medium / (L) Front Trim - Grime - Small / (L) Front Floor Mat - Missing - Yes</p>	<p><b>Remarks</b> Front Bumper, Grille, Lamps - Repair mark - Yes / Front Bumper, Grille, Lamps - Scratch &amp; Dent - Large / (L) Rear Fender, Molding - Scratch &amp; Dent - Small / (R) Front Door, Molding - Repair mark - Yes / (R) Front Door, Molding - Scratch - Small / (R) Step, In-panel, Side Spoiler - Repair mark - Yes / (R) Rear Door, Molding - Scratch - Minimal / (R) Rear Fender, Molding - Scratch - Small / Rear Bumper, Lamps, Panels - Repair mark - Yes / Rear Bumper, Lamps, Panels - Scratch - Small / (L) Step, In-panel, Side Spoiler - Scratch - Small / (L) Front Door, Molding - Dent - Small / Roof - Dent - Small</p>
