General Information

Date & Time: 31, May, 2025 13:42

Make	Toyota	Model	Innova
YOM	2023	Odo Meter Reading	17,732
Registration No.	NIT4460	Chassis No.	PA2JA8EM0P0128924
CC	2.8	Transmission	A/T
Fuel Type	Diesel	Type of Body	Wagon
Colour	Red

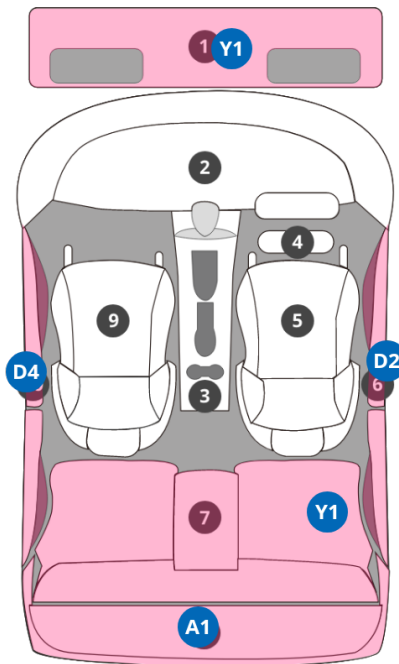
Interior Evaluation : C	Exterior Evaluation : C

<p>a : Cut, Fray d : Loose, Deformed k : Animal Hair s : Smell t : Cigarette Burns x : Defective y : Stain</p>

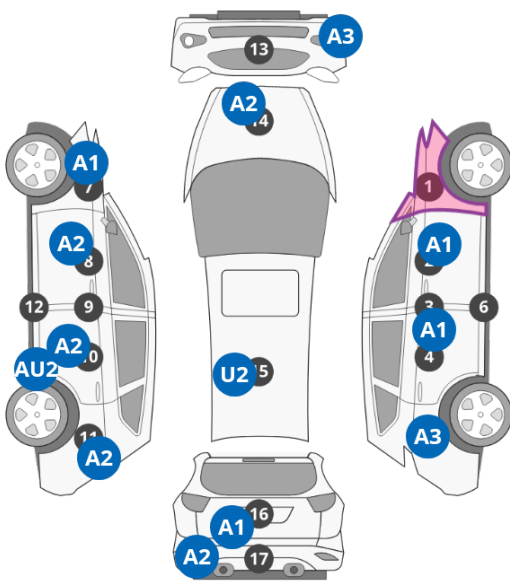
<p>A : Scratch AU : Scratch & Dent B : Modified C : Corrosion G : Stone chip P : Faded S : Rust SC : Rust & Corrosion U : Dent X : Defective Y : Crack, Gap</p>
<p>Remarks Rear Seat - Grime - Minimal / (R) Front Trim - Worked - Small / Trunk Room - Worn, Scratch, Cut, Crack - Minimal / (L) Front Trim - Worked - Large / Ceiling - Grime - Minimal</p>	<p>Remarks (R) Front Fender - Repair Traces - Yes / (R) Front Fender, Molding - Repair mark - Yes / (R) Front Door, Molding - Scratch - Minimal / (R) Rear Door, Molding - Scratch - Minimal / (R) Rear Fender, Molding - Scratch - Medium / Rear Bumper, Lamps, Panels - Scratch - Small / Trunk Hood, Rear Gate - Scratch - Minimal / (L) Rear Fender, Molding - Scratch - Small / (L) Step, In-panel, Side Spoiler - Scratch & Dent - Small / (L) Rear Door, Molding - Scratch - Small / Roof - Dent - Small / (L) Front Door, Molding - Scratch - Small / (L) Front Fender, Molding - Scratch - Minimal / Front Bumper, Grille, Lamps - Scratch - Medium / Bonnet, Headlight - Scratch - Small</p>
