## General Information

| <b>Make</b> | Toyota | <b>Model</b> | Vios |
| <b>Registration No.</b> | CBT9945 | <b>Chassis No.</b> | PA1B18F37P4206431 |

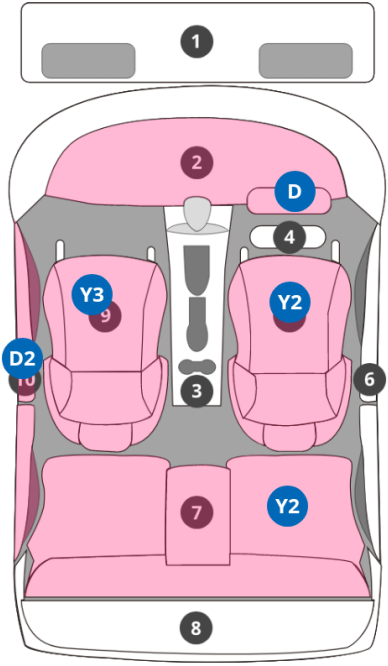
| <p><b>Remarks</b><br/>(R) Front Seat - Grime - Small / (L) Front Seat - Grime - Medium / Rear Seat - Grime - Small / (L) Front Trim - Worked - Small / Glove Box - Traces of Adhesive Tape - Yes</p> | <p><b>Remarks</b><br/>(L) Front Fender - Repair Traces - Yes / (L) Front Door, Molding - Scratch - Small / (L) Rear Door, Molding - Scratch &amp; Dent - Minimal / (L) Rear Fender, Molding - Scratch - Small / (L) Front Fender, Molding - Repair mark - Yes / Rear Bumper, Lamps, Panels - Scratch &amp; Dent - Small / Trunk Hood, Rear Gate - Scratch - Small / (R) Rear Door, Molding - Scratch - Small / (R) Front Door, Molding - Scratch - Minimal / (R) Step, In-panel, Side Spoiler - Scratch &amp; Dent - Large / Member (Bolted) - Dent - Yes / Bonnet, Headlight - Scratch - Minimal</p> |
