## General Information

<b>Make</b>	Toyota	<b>Model</b>	Raize
<b>YOM</b>	2025	<b>Odo Meter Reading</b>	4,629
<b>Registration No.</b>	NHU3050	<b>Chassis No.</b>	MHKAB1BA6RJ097163
<b>CC</b>	1.2	<b>Transmission</b>	CVT
<b>Fuel Type</b>	Gas	<b>Type of Body</b>	SUV
<b>Colour</b>	Gray

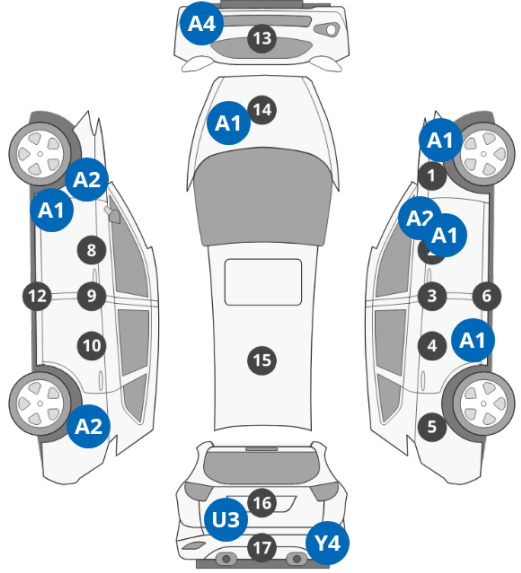
<p><b>A</b> : Scratch <b>AU</b> : Scratch &amp; Dent <b>B</b> : Modified <b>C</b> : Corrosion <b>G</b> : Stone chip <b>P</b> : Faded <b>S</b> : Rust <b>SC</b> : Rust &amp; Corrosion <b>U</b> : Dent <b>X</b> : Defective <b>Y</b> : Crack, Gap</p>
<p><b>Remarks</b>  Rear Seat - Grime - Medium / (R) Front Floor Mat - Grime - Medium / (R) Front Seat - Grime - Small / (L) Front Floor Mat - Grime - Medium / Console, Switches, Vents - Traces of Adhesive Tape - Yes / (L) Front Seat - Grime - Medium</p>	<p><b>Remarks</b>  (R) Mirror - Scratch - Small / (R) Front Fender, Molding - Scratch - Minimal / (R) Front Door, Molding - Scratch - Minimal / (R) Rear Door, Molding - Scratch - Minimal / Rear Bumper, Lamps, Panels - Crack, Gap - Large / Trunk Hood, Rear Gate - Dent - Medium / (L) Rear Fender, Molding - Scratch - Small / (L) Front Fender, Molding - Scratch - Small / (L) Front Door, Molding - Scratch - Minimal / Front Bumper, Grille, Lamps - Scratch - Large / Bonnet, Headlight - Scratch - Minimal</p>
