## General Information

| Make | Toyota | Model | Hiace |
| Registration No. | DA620B | Chassis No. | JTFNAFAP7S8055428 |

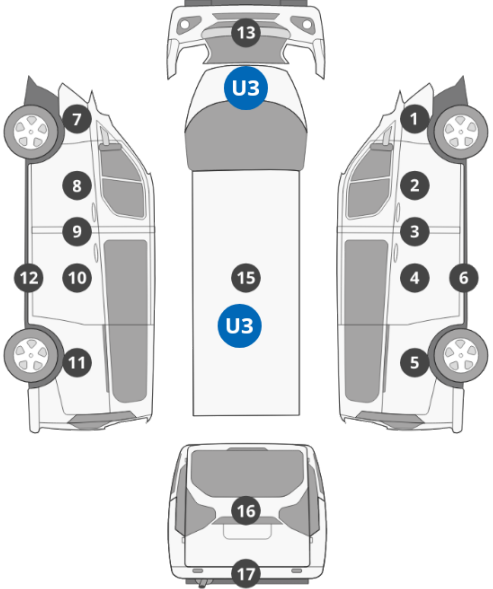
| Interior Evaluation : <b>A</b> | Exterior Evaluation : <b>B</b> |
| <b>Remarks</b><br>Defects not found | <b>Remarks</b><br>Roof - Dent - Medium / Bonnet, Headlight - Dent - Medium |

| Inspector Notes |
|---|
| Cluster of dents on Hood and roof |
