General Information

Date & Time: 04, Jun, 2025 08:15

Make	Toyota	Model	Hilux
YOM	2022	Odo Meter Reading	51,422
Registration No.	NFG9407	Chassis No.	MR0JB8DD0M3186171
CC	2.4	Transmission	M/T
Fuel Type	Diesel	Type of Body	Pickup
Colour	Black

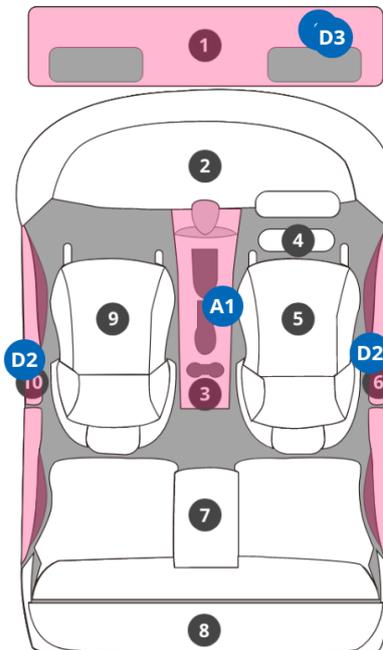
Interior Evaluation : C	Exterior Evaluation : E

<p>a : Cut, Fray d : Loose, Deformed k : Animal Hair s : Smell t : Cigarette Burns x : Defective y : Stain</p>

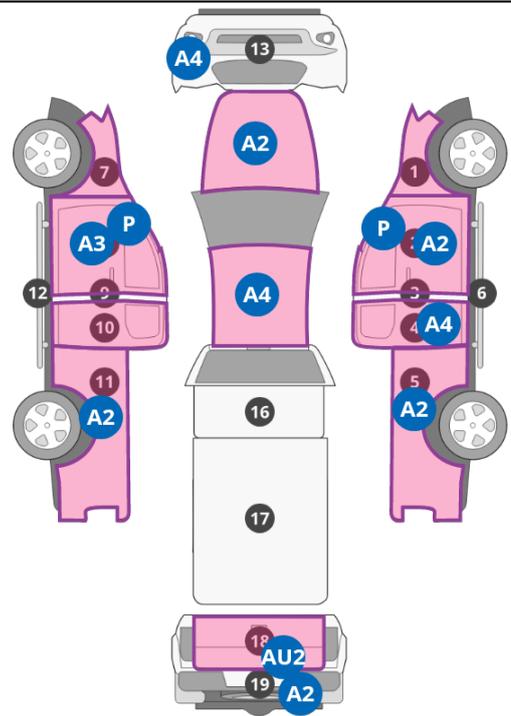
<p>A : Scratch AU : Scratch & Dent B : Modified C : Corrosion G : Stone chip P : Faded S : Rust SC : Rust & Corrosion U : Dent X : Defective Y : Crack, Gap</p>
<p>Remarks Overall Interior - Worn as per age - Yes / Overall Interior - Smell - Yes / Ceiling - Crinkle - Medium / Console, Switchs, Vents - Worn, Scratch, Cut, Crack - Minimal / (L) Front Trim - Worked - Small / (R) Front Trim - Worked - Small</p>	<p>Remarks (R) Front Door - Repair Traces - Yes / (R) Front Fender - Repair Traces - Yes / Bonnet - Repair Traces - Yes / (L) Front Fender - Repair Traces - Yes / (L) Front Door - Repair Traces - Yes / (L) Rear Door - Repair Traces - Yes / (L) Rear Corner Panel - Repair Traces - Yes / (R) Rear Door - Repair Traces - Yes / Roof - Repair Traces - Yes / (R) Front Door, Molding - Repair mark - Yes / (R) Rear Door, Molding - Repair mark - Yes / (R) Side Gate - Repair mark - Yes / (L) Side Gate - Repair mark - Yes / Rear Gate - Repair mark - Yes / Roof - Repair mark - Yes / Bonnet, Headlight - Repair mark - Yes / (R) Front Fender, Molding - Repair mark - Yes / (L) Front Door, Molding - Repair mark - Yes / (L) Rear Door, Molding - Repair mark - Yes / (L) Front Fender, Molding - Repair mark - Yes / Rear Gate - Scratch & Dent - Small / Rear Bumper, Lamps, Panels - Scratch - Small / (L) Side Gate - Scratch - Small / (L) Front Door, Molding - Scratch - Medium / (L) Front Fender, Molding - Partially Missing - Yes / Front Bumper, Grille, Lamps - Scratch - Large / (R) Front Fender, Molding - Partially Missing - Yes / (R) Rear Door, Molding - Scratch - Large / (R) Front Door, Molding - Scratch - Small / (R) Mirror - Faded(Color, Gloss) - Yes / (L) Mirror - Faded(Color, Gloss) - Yes / (R) Side Gate - Scratch - Small / Roof - Scratch - Large / Bonnet, Headlight - Scratch - Small</p>
