## General Information

<b>Make</b>	Toyota	<b>Model</b>	Innova
<b>YOM</b>	2023	<b>Odo Meter Reading</b>	38,836
<b>Registration No.</b>	DBH9694-1	<b>Chassis No.</b>	PA2JA8EMXP0123844
<b>CC</b>	2.8	<b>Transmission</b>	A/T
<b>Fuel Type</b>	Diesel	<b>Type of Body</b>	Wagon
<b>Colour</b>	Red Mica Metallic

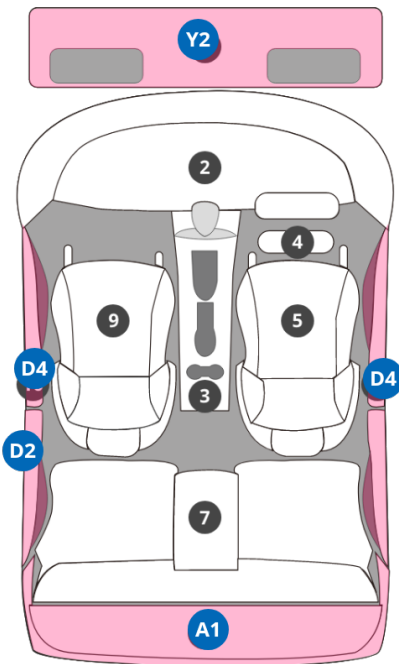
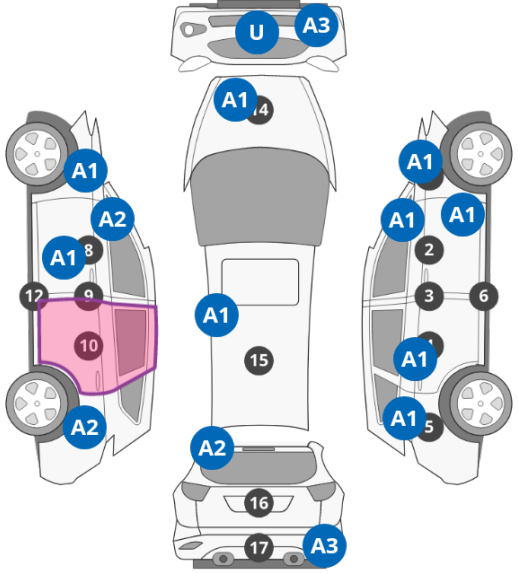
<p><b>a</b> : Cut, Fray <b>d</b> : Loose, Deformed <b>k</b> : Animal Hair <b>s</b> : Smell <b>t</b> : Cigarette Burns <b>x</b> : Defective <b>y</b> : Stain</p>		<p><b>A</b> : Scratch <b>AU</b> : Scratch &amp; Dent <b>B</b> : Modified <b>C</b> : Corrosion <b>G</b> : Stone chip <b>P</b> : Faded <b>S</b> : Rust <b>SC</b> : Rust &amp; Corrosion <b>U</b> : Dent <b>X</b> : Defective <b>Y</b> : Crack, Gap</p>	
<p><b>Remarks</b> Trunk Room - Worn, Scratch, Cut, Crack - Minimal / (L) Rear Trim - Worked - Small / Ceiling - Grime - Small / (R) Front Trim - Worked - Large / (L) Front Trim - Worked - Large</p>		<p><b>Remarks</b> (L) Rear Door - Repair Traces - Yes / (R) Front Fender, Molding - Scratch - Minimal / (L) Rear Door, Molding - Repair mark - Yes / (R) Front Door, Molding - Scratch - Minimal / (R) Mirror - Scratch - Minimal / (R) Rear Door, Molding - Scratch - Minimal / (R) Rear Fender, Molding - Scratch - Minimal / Rear Bumper, Lamps, Panels - Scratch - Medium / Trunk Hood, Rear Gate - Scratch - Small / (L) Rear Fender, Molding - Scratch - Small / (L) Front Door, Molding - Scratch - Minimal / (L) Mirror - Scratch - Small / (L) Front Fender, Molding - Scratch - Minimal / Front Bumper, Grille, Lamps - Scratch - Medium / Member (Bolted) - Dent - Yes / Bonnet, Headlight - Scratch - Minimal / Roof - Scratch - Minimal</p>
