## General Information

| <b>Make</b> | Toyota | <b>Model</b> | Vios |
| <b>Registration No.</b> | NFP7910-1 | <b>Chassis No.</b> | PA1B18F32N4194301 |

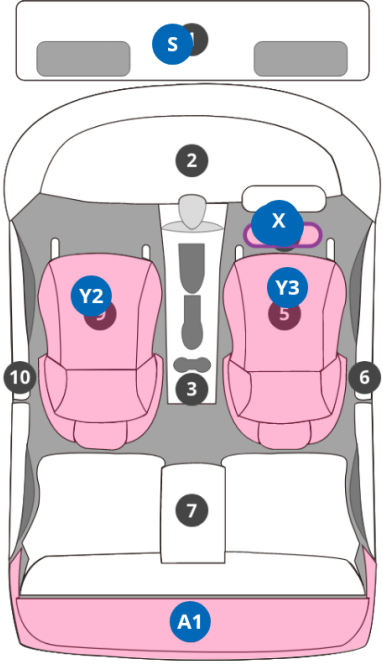
| <b>Interior Evaluation :</b> <span style="float: right;"><b>B</b></span> | <b>Exterior Evaluation :</b> <span style="float: right;"><b>E</b></span> |

| <p><b>Remarks</b><br/>Trunk Room - Worn, Scratch, Cut, Crack - Minimal / Mat Other - Missing - Yes / (R) Front Floor Mat - Missing - Yes / (L) Front Floor Mat - Missing - Yes / Overall Interior - Smell - Yes / (L) Front Seat - Grime - Small / (R) Front Seat - Grime - Medium</p> | <p><b>Remarks</b><br/>(R) Front Door, Molding - Repair mark - Yes / (R) Rear Door, Molding - Repair mark - Yes / (R) Rear Fender, Molding - Repair mark - Yes / (R) Front Fender, Molding - Repair mark - Yes / Trunk Hood, Rear Gate - Modified - Medium / Rear Bumper, Lamps, Panels - Repair mark - Yes / (R) Front Fender, Molding - Scratch - Minimal / (R) Step, In-panel, Side Spoiler - Scratch - Large / (R) Front Door, Molding - Scratch - Minimal / (R) Rear Door, Molding - Scratch - Minimal / Roof - Scratch - Small / Rear Bumper, Lamps, Panels - Dent - Medium / Trunk Hood, Rear Gate - Scratch &amp; Dent - Small / (L) Rear Fender, Molding - Scratch - Minimal / (L) Mirror - Scratch - Minimal / (L) Rear Door, Molding - Scratch - Minimal / (L) Front Door, Molding - Scratch - Minimal / (L) Front Fender, Molding - Scratch - Minimal / Front Bumper, Grille, Lamps - Scratch - Medium / Bonnet, Headlight - Scratch - Small</p> |

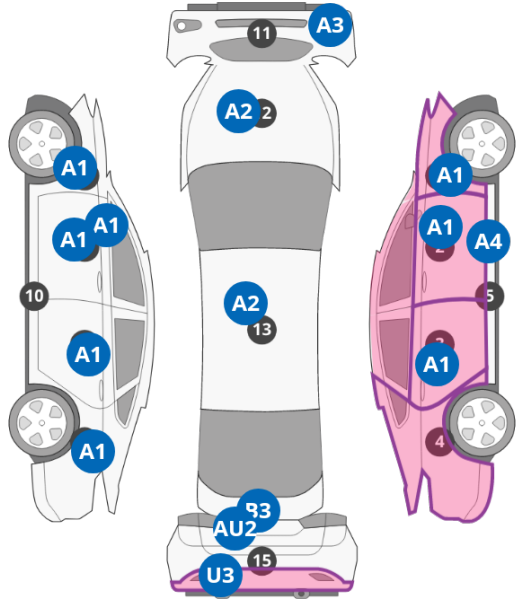
| <p>with LTO plate, no warranty booklet, no jack, incomplete tools, no spare tire, stain and scratches on tail light, drill marks on trunk hood, no reverse camera</p> |
