## General Information

Date & Time: 19, Jun, 2025 10:55

<b>Make</b>	Toyota	<b>Model</b>	Innova
<b>YOM</b>	2017	<b>Odo Meter Reading</b>	132,135
<b>Registration No.</b>	CAC2512	<b>Chassis No.</b>	PA2GA8EM5G0016078
<b>CC</b>	2.8	<b>Transmission</b>	A/T
<b>Fuel Type</b>	Diesel	<b>Type of Body</b>	MPV
<b>Colour</b>	Red Mica Metallic

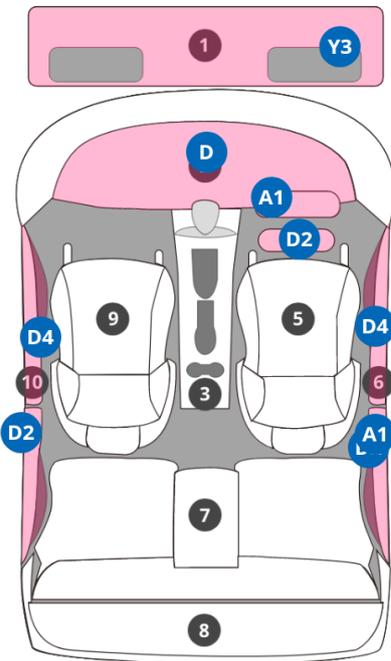
<b>Interior Evaluation :</b> <span style="float: right; color: red; font-weight: bold;">C</span>	<b>Exterior Evaluation :</b> <span style="float: right; color: red; font-weight: bold;">E</span>

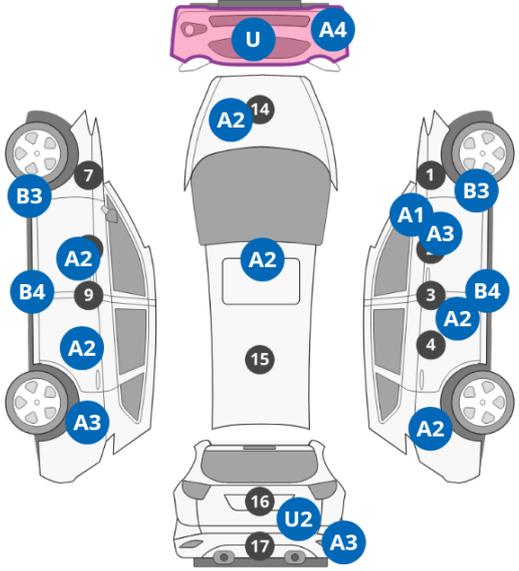
<p><b>A</b> : Scratch <b>AU</b> : Scratch &amp; Dent <b>B</b> : Modified <b>C</b> : Corrosion <b>G</b> : Stone chip <b>P</b> : Faded <b>S</b> : Rust <b>SC</b> : Rust &amp; Corrosion <b>U</b> : Dent <b>X</b> : Defective <b>Y</b> : Crack, Gap</p>
<p><b>Remarks</b> Overall Interior - Worn as per age - Yes / Ceiling - Grime - Medium / (R) Rear Trim - Worked - Small / (L) Rear Trim - Worked - Small / (R) Front Trim - Worked - Large / (L) Front Trim - Worked - Large / (R) Rear Trim - Cut, Crack - Minimal / Dashboard - Worn, Scratch, Cut, Crack - Minimal / Dashboard - Traces of Adhesive Tape - Yes / (L) Front Floor Mat - Worked - Small</p>	<p><b>Remarks</b> (L) Front Fender - Repair Traces - Yes / Trunk Hood, Rear Gate - Repair Traces - Yes / (R) Mirror - Scratch - Minimal / (R) Step, In-panel, Side Spoiler - Modified - Large / (L) Step, In-panel, Side Spoiler - Modified - Large / (R) Rear Door, Molding - Scratch - Small / (R) Front Door, Molding - Scratch - Medium / (R) Front Fender, Molding - Modified - Medium / (R) Rear Fender, Molding - Scratch - Small / Rear Bumper, Lamps, Panels - Scratch - Medium / Trunk Hood, Rear Gate - Dent - Small / (L) Rear Fender, Molding - Scratch - Medium / (L) Rear Door, Molding - Scratch - Small / (L) Front Fender, Molding - Modified - Medium / (L) Front Door, Molding - Scratch - Small / Member (Bolted) - Dent - Yes / Front Bumper, Grille, Lamps - Repair mark - Yes / Front Bumper, Grille, Lamps - Scratch - Large / Bonnet, Headlight - Scratch - Small / Roof - Scratch - Small</p>
