## General Information

Date & Time: 05, Jun, 2025 14:02

<b>Make</b>	Toyota	<b>Model</b>	Vios
<b>YOM</b>	2022	<b>Odo Meter Reading</b>	8,442
<b>Registration No.</b>	NFJ4059	<b>Chassis No.</b>	PA1B18F35N4172373
<b>CC</b>	1.3	<b>Transmission</b>	CVT
<b>Fuel Type</b>	Gas	<b>Type of Body</b>	Sedan
<b>Colour</b>	Blackish Red Mica

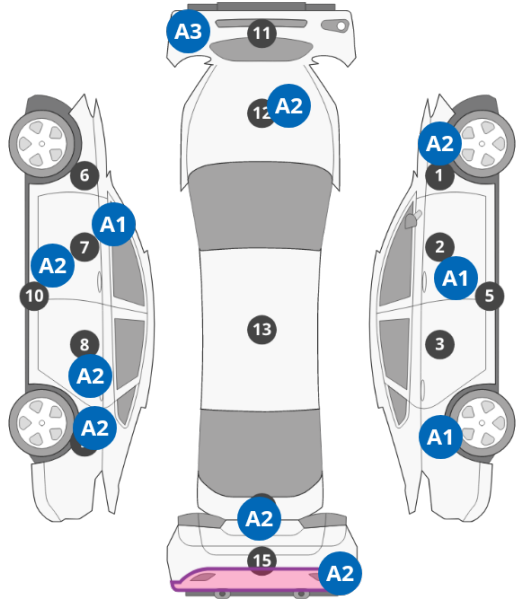
<p><b>A</b> : Scratch <b>AU</b> : Scratch &amp; Dent <b>B</b> : Modified <b>C</b> : Corrosion <b>G</b> : Stone chip <b>P</b> : Faded <b>S</b> : Rust <b>SC</b> : Rust &amp; Corrosion <b>U</b> : Dent <b>X</b> : Defective <b>Y</b> : Crack, Gap</p>
<p><b>Remarks</b> (R) Front Floor Mat - Missing - Yes / (L) Front Floor Mat - Missing - Yes / Mat Other - Missing - Yes / (R) Front Trim - Grime - Small / (L) Front Trim - Grime - Small / Ceiling - Grime - Minimal</p>	<p><b>Remarks</b> (L) Front Fender - Repair Traces - Yes / Rear Bumper, Lamps, Panels - Repair mark - Yes / (L) Rear Fender, Molding - Scratch - Small / (L) Rear Door, Molding - Scratch - Small / (L) Front Door, Molding - Scratch - Small / (L) Mirror - Scratch - Minimal / Front Bumper, Grille, Lamps - Scratch - Medium / Bonnet, Headlight - Scratch - Small / (R) Front Fender, Molding - Scratch - Small / (R) Front Door, Molding - Scratch - Minimal / (R) Rear Fender, Molding - Scratch - Minimal / Trunk Hood, Rear Gate - Scratch - Small / Rear Bumper, Lamps, Panels - Scratch - Small</p>
