General Information

Date & Time: 05, Jun, 2025 18:27

Make	Toyota	Model	Hiace
YOM	2024	Odo Meter Reading	6,875
Registration No.	NHM3729	Chassis No.	JTFJT02P5035658
CC	3.0	Transmission	M/T
Fuel Type	Diesel	Type of Body	Van
Colour	White

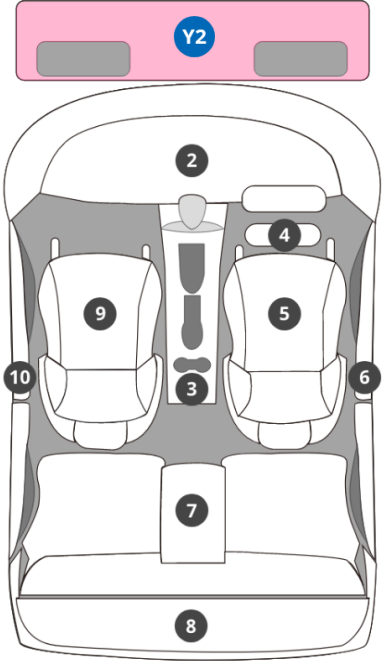
Interior Evaluation : A	Exterior Evaluation : B

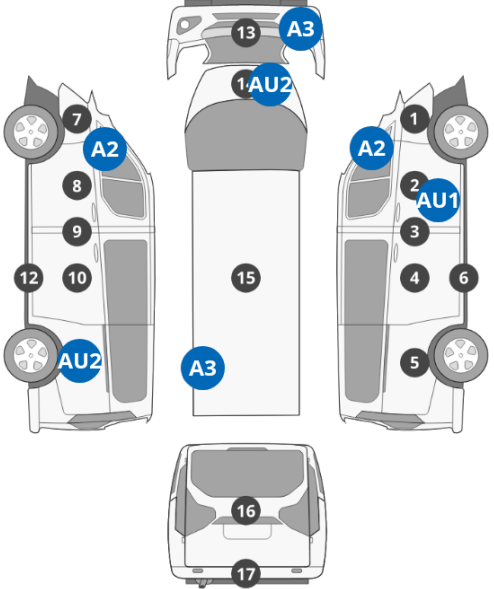
<p>A : Scratch AU : Scratch & Dent B : Modified C : Corrosion G : Stone chip P : Faded S : Rust SC : Rust & Corrosion U : Dent X : Defective Y : Crack, Gap</p>
Remarks Ceiling - Grime - Small	Remarks (L) Rear Fender, Molding - Scratch & Dent - Small / (L) Mirror - Scratch - Small / Bonnet, Headlight - Scratch & Dent - Small / Front Bumper, Grille, Lamps - Scratch - Medium / (R) Mirror - Scratch - Small / (R) Front Door, Molding - Scratch & Dent - Minimal / Roof - Scratch - Medium
Frame Evaluation : A	Functional Evaluation : A
Remarks Defects not found	Remarks Reverse Camera - N/A - Yes
