## General Information

<b>Make</b>	Toyota	<b>Model</b>	Hilux
<b>YOM</b>	2024	<b>Odo Meter Reading</b>	52,479
<b>Registration No.</b>	BAF7454	<b>Chassis No.</b>	MR0JB8DD6P3224197
<b>CC</b>	2.4	<b>Transmission</b>	A/T
<b>Fuel Type</b>	Diesel	<b>Type of Body</b>	Pickup
<b>Colour</b>	White

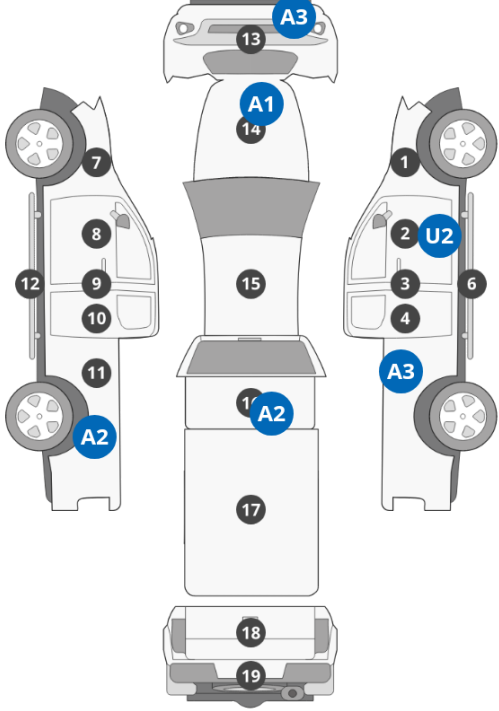
<p><b>A</b> : Scratch <b>AU</b> : Scratch &amp; Dent <b>B</b> : Modified <b>C</b> : Corrosion <b>G</b> : Stone chip <b>P</b> : Faded <b>S</b> : Rust <b>SC</b> : Rust &amp; Corrosion <b>U</b> : Dent <b>X</b> : Defective <b>Y</b> : Crack, Gap</p>
<p><b>Remarks</b>          Ceiling - Grime - Small / (R) Front Trim - Grime - Medium / (R) Rear Trim - Grime - Small / (R) Front Floor Mat - Grime - Small / (L) Rear Trim - Grime - Small / (L) Front Trim - Grime - Medium / (L) Front Seat - Grime - Medium</p>	<p><b>Remarks</b>          (L) Side Gate - Scratch - Small / (R) Side Gate - Scratch - Medium / Bonnet, Headlight - Scratch - Minimal / Front Bumper, Grille, Lamps - Scratch - Medium / (R) Front Door, Molding - Dent - Small / Cab Back Panel - Scratch - Small</p>
