General Information

Date & Time: 13, Jun, 2025 09:54

Make	Suzuki	Model	Carry
YOM	2023	Odo Meter Reading	38,219
Registration No.	NHE6929	Chassis No.	MHYDC61TXPJ213509
CC	1.5	Transmission	M/T
Fuel Type	Gas	Type of Body	Van
Colour	White

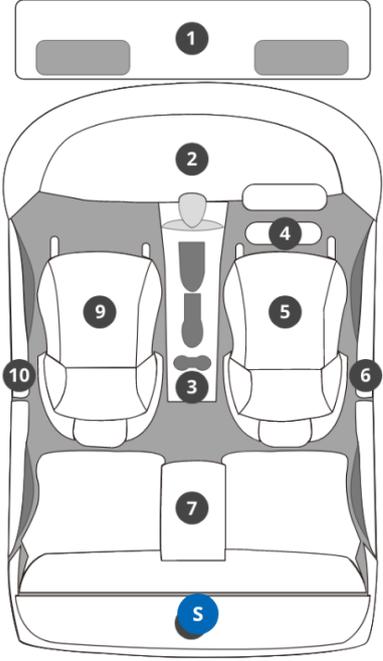
Interior Evaluation : C	Exterior Evaluation : E

<p>a : Cut, Fray d : Loose, Deformed k : Animal Hair s : Smell t : Cigarette Burns x : Defective y : Stain</p>

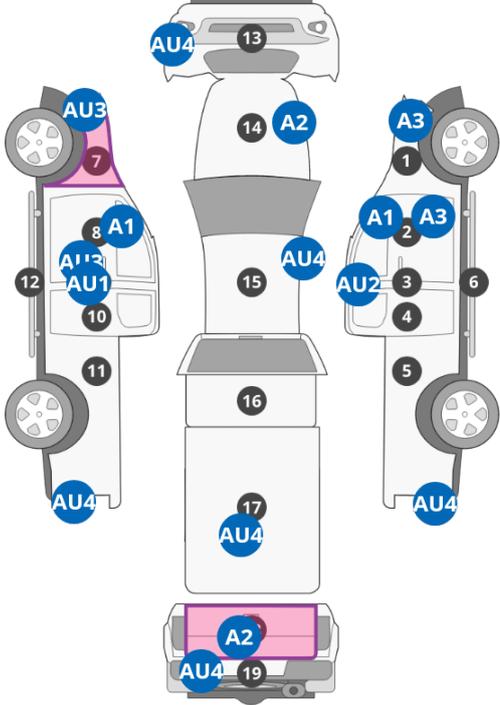
<p>A : Scratch AU : Scratch & Dent B : Modified C : Corrosion G : Stone chip P : Faded S : Rust SC : Rust & Corrosion U : Dent X : Defective Y : Crack, Gap</p>
<p>Remarks Overall Interior - Smell - Yes / Overall Interior - Worn as per age - Yes</p>	<p>Remarks (L) Rear Corner Panel - Repair Traces - Yes / (R) Rear Corner Panel - Repair Traces - Yes / Rear Gate - Repair mark - Yes / (L) Front Fender, Molding - Repair mark - Yes / (R) Front Fender, Molding - Scratch - Medium / (R) Front Door, Molding - Scratch - Medium / (R) Center Panel - Scratch & Dent - Small / (R) Side Gate - Scratch & Dent - Large / Rear Bumper, Lamps, Panels - Scratch & Dent - Large / Rear Gate - Scratch - Small / Cargo Bed Floor - Scratch & Dent - Large / (L) Side Gate - Scratch & Dent - Large / (L) Front Door, Molding - Scratch & Dent - Medium / Front Bumper, Grille, Lamps - Scratch & Dent - Large / (L) Front Fender, Molding - Scratch & Dent - Medium / (L) Mirror - Scratch - Minimal / (R) Mirror - Scratch - Minimal / Front Panel - Scratch - Small / (L) Center Panel - Scratch & Dent - Minimal / Roof - Scratch & Dent - Large</p>
