General Information

Date & Time: 11, Jun, 2025 14:46

Make	Toyota	Model	Vios
YOM	2024	Odo Meter Reading	26,462
Registration No.	NHR1951	Chassis No.	PA1B18F30P4226438
CC	1.3	Transmission	CVT
Fuel Type	Gas	Type of Body	Sedan
Colour	Red Mica Metallic

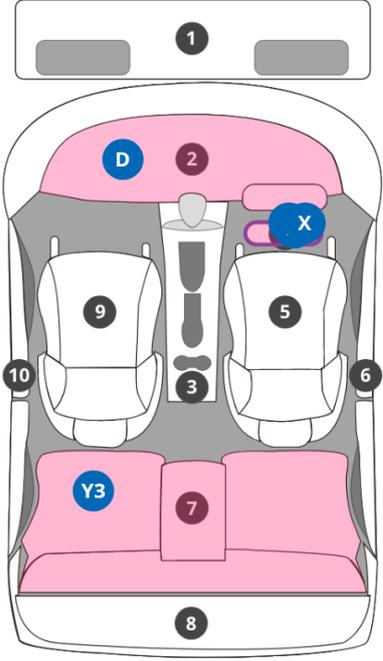
Interior Evaluation : B	Exterior Evaluation : C

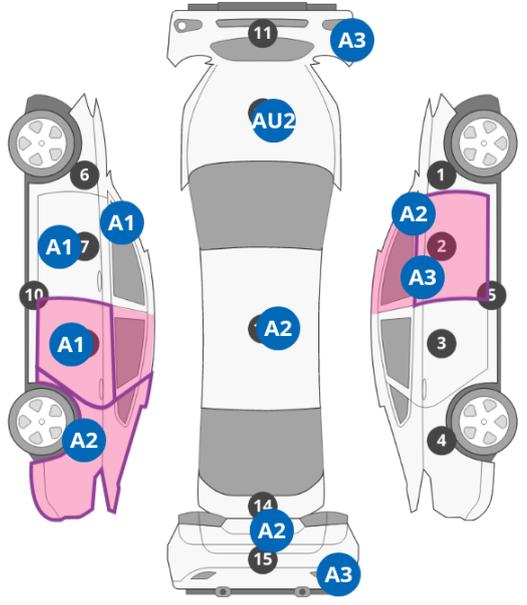
<p>A : Scratch AU : Scratch & Dent B : Modified C : Corrosion G : Stone chip P : Faded S : Rust SC : Rust & Corrosion U : Dent X : Defective Y : Crack, Gap</p>
<p>Remarks (R) Front Floor Mat - Missing - Yes / (L) Front Floor Mat - Missing - Yes / Mat Other - Missing - Yes / Dashboard - Traces of Adhesive Tape - Yes / Rear Seat - Grime - Medium</p>	<p>Remarks (R) Front Door - Repair Traces - Yes / (L) Front Fender - Repair Traces - Yes / (L) Rear Door - Repair Traces - Yes / (L) Rear Fender - Repair Traces - Yes / Trunk Hood, Rear Gate - Repair Traces - Yes / (R) Rear Fender - Repair Traces - Yes / Roof - Repair Traces - Yes / (L) Rear Fender, Molding - Repair mark - Yes / (R) Front Door, Molding - Repair mark - Yes / (L) Rear Door, Molding - Repair mark - Yes / Trunk Hood, Rear Gate - Scratch - Small / Rear Bumper, Lamps, Panels - Scratch - Medium / (R) Front Door, Molding - Scratch - Medium / (R) Mirror - Scratch - Small / Front Bumper, Grille, Lamps - Scratch - Medium / Bonnet, Headlight - Scratch & Dent - Small / (L) Mirror - Scratch - Minimal / (L) Rear Fender, Molding - Scratch - Small / Roof - Scratch - Small / (L) Rear Door, Molding - Scratch - Minimal / (L) Front Door, Molding - Scratch - Minimal</p>
