## General Information

| Make | Toyota | Model | Vios |
| Registration No. | DBM9242 | Chassis No. | PA1B18F30R4243890 |

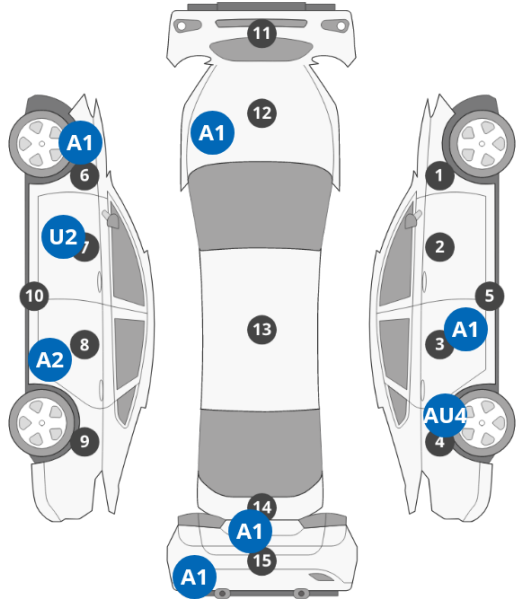
| Interior Evaluation : <span style="color: red; font-weight: bold;">A</span> | Exterior Evaluation : <span style="color: red; font-weight: bold;">C</span> |
|---|---|
| <b>Remarks</b><br>Defects not found | <b>Remarks</b><br>(R) Rear Fender, Molding - Scratch & Dent - Large / Rear Bumper, Lamps, Panels - Scratch - Minimal / (L) Rear Door, Molding - Scratch - Small / (L) Front Door, Molding - Dent - Small / Bonnet, Headlight - Scratch - Minimal / (R) Rear Door, Molding - Scratch - Minimal / Trunk Hood, Rear Gate - Scratch - Minimal / (L) Front Fender, Molding - Scratch - Minimal |

| Inspector Notes |
|---|
| slight discolouration between body and bumpers (front and rear) |
