## General Information

| Make | Honda | Model | City |
| Registration No. | NEH5137 | Chassis No. | PADGM6620KV517993 |

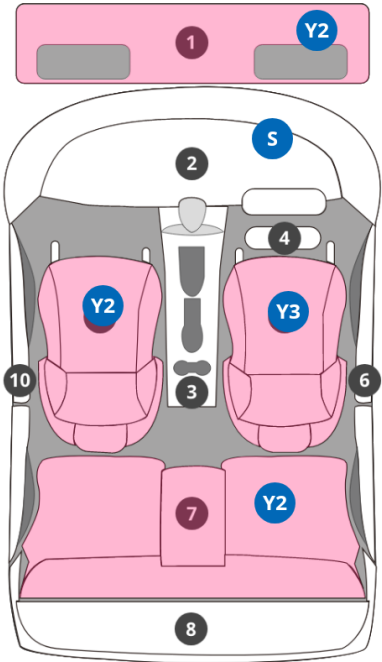
| Interior Evaluation : <span style="color: red;">C</span> | Exterior Evaluation : <span style="color: red;">E</span> |
|---|---|
| <b>Remarks</b><br>Overall Interior - Worn as per age - Yes / Overall Interior - Smell - Yes / Ceiling - Grime - Small / (R) Front Seat - Grime - Medium / (L) Front Seat - Grime - Small / Rear Seat - Grime - Small | <b>Remarks</b><br>(R) Front Door - Repair Traces - Yes / (R) Front Fender - Repair Traces - Yes / Bonnet - Repair Traces - Yes / (L) Front Door - Repair Traces - Yes / (L) Rear Door - Repair Traces - Yes / (R) Rear Door - Repair Traces - Yes / Roof - Repair Traces - Yes / (R) Front Door, Molding - Repair mark - Yes / (R) Rear Door, Molding - Repair mark - Yes / (R) Rear Fender, Molding - Repair mark - Yes / (L) Rear Fender, Molding - Repair mark - Yes / (L) Rear Door, Molding - Repair mark - Yes / (L) Front Door, Molding - Repair mark - Yes / Bonnet, Headlight - Repair mark - Yes / (R) Step, In-panel, Side Spoiler - Scratch & Dent - Medium / (R) Front Door, Molding - Scratch - Small / (R) Rear Door, Molding - Scratch & Dent - Small / (R) Rear Fender, Molding - Scratch & Dent - Small / Rear Bumper, Lamps, Panels - Scratch - Small / Trunk Hood, Rear Gate - Dent - Small / (L) Front Wheel, Cover - Cap Missing - Yes / (R) Front Wheel, Cover - Cap Missing - Yes / (R) Rear Wheel, Cover - Cap Missing - Yes / (L) Rear Door, Molding - Scratch - Small / (L) Front Door, Molding - Scratch - Small / (L) Rear Fender, Molding - Scratch - Small / Roof - Scratch - Small / Bonnet, Headlight - Scratch - Medium / (R) Front Fender, Molding - Crack, Gap - Medium / Front Bumper, Grille, Lamps - Crack, Gap - Medium / (R) Mirror - Crack - Damaged |
