General Information

Date & Time: 07, Jun, 2025 15:17

Make	Nissan	Model	NV350
YOM	2017	Odo Meter Reading	78,558
Registration No.	NAR1823	Chassis No.	JN1TC2E26Z0011872
CC	2.5	Transmission	M/T
Fuel Type	Diesel	Type of Body	Van
Colour	White

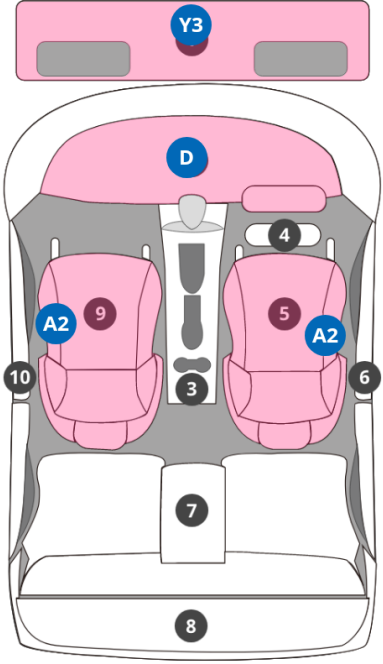
Interior Evaluation : B	Exterior Evaluation : D

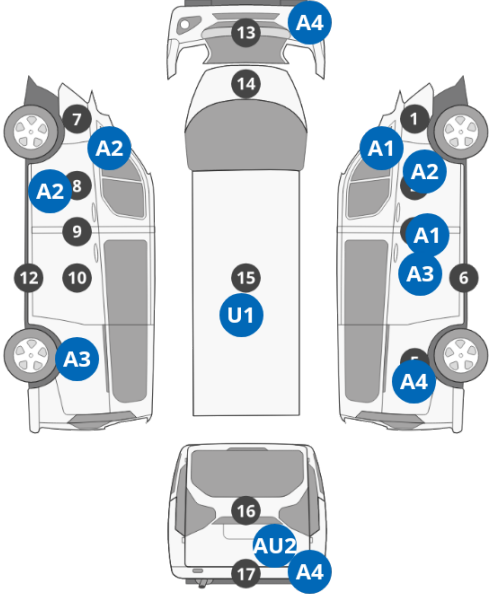
<p>A : Scratch AU : Scratch & Dent B : Modified C : Corrosion G : Stone chip P : Faded S : Rust SC : Rust & Corrosion U : Dent X : Defective Y : Crack, Gap</p>
<p>Remarks Ceiling - Grime - Medium / (R) Front Seat - Cut, Crack - Small / (L) Front Seat - Cut, Crack - Small / Dashboard - Traces of Adhesive Tape - Yes</p>	<p>Remarks (R) Front Door - Repair Traces - Yes / (R) Front Fender - Repair Traces - Yes / Bonnet - Repair Traces - Yes / (L) Front Fender - Repair Traces - Yes / (L) Front Door - Repair Traces - Yes / (L) Rear Fender - Repair Traces - Yes / Trunk Hood, Rear Gate - Repair Traces - Yes / (R) Rear Fender - Repair Traces - Yes / (R) Rear Door - Repair Traces - Yes / Roof - Repair Traces - Yes / (R) Mirror - Scratch - Minimal / (R) Center Panel - Scratch - Minimal / (R) Rear Door, Molding - Scratch - Medium / (R) Front Door, Molding - Scratch - Small / (R) Rear Fender, Molding - Scratch - Large / Trunk Hood, Rear Gate - Scratch & Dent - Small / Rear Bumper, Lamps, Panels - Scratch - Large / (L) Rear Fender, Molding - Scratch - Medium / (L) Front Door, Molding - Scratch - Small / (L) Mirror - Scratch - Small / Front Bumper, Grille, Lamps - Scratch - Large / Roof - Dent - Minimal</p>
