General Information

Make	Toyota	Model	Wigo
YOM	2018	Odo Meter Reading	47,330
Registration No.	DAD2643	Chassis No.	MHKA4DF5FJJ020068
CC	1.0	Transmission	A/T
Fuel Type	Gas	Type of Body	Hatchback
Colour	White

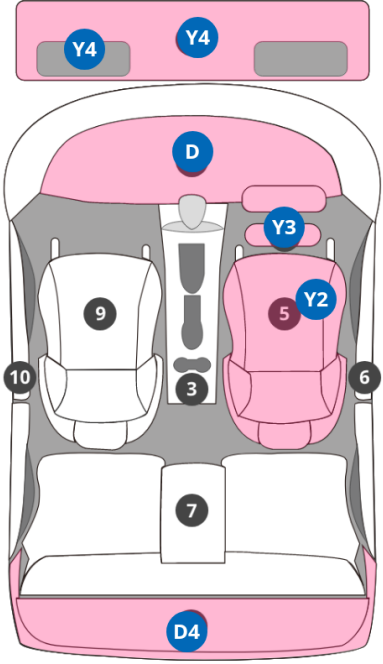
Interior Evaluation : C	Exterior Evaluation : C

<p>a : Cut, Fray d : Loose, Deformed k : Animal Hair s : Smell t : Cigarette Burns x : Defective y : Stain</p>

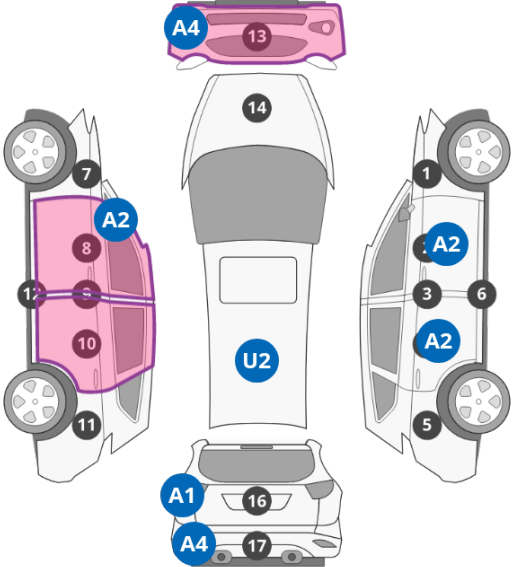
<p>A : Scratch AU : Scratch & Dent B : Modified C : Corrosion G : Stone chip P : Faded S : Rust SC : Rust & Corrosion U : Dent X : Defective Y : Crack, Gap</p>
<p>Remarks Sunvisor, Sunglass Holder - Grime - Large / Ceiling - Grime - Large / (R) Front Seat - Grime - Small / Trunk Room - Loose, Deformed - Large / Mat Other - Grime - Medium / Dashboard - Traces of Adhesive Tape - Yes</p>	<p>Remarks (L) Front Door - Repair Traces - Yes / (L) Step - Repair Traces - Yes / (L) Rear Door - Repair Traces - Yes / (L) Front Door, Molding - Repair mark - Yes / (L) Rear Door, Molding - Repair mark - Yes / Roof - Dent - Small / Rear Bumper, Lamps, Panels - Scratch - Large / (R) Front Door, Molding - Scratch - Small / (R) Rear Door, Molding - Scratch - Small / Front Bumper, Grille, Lamps - Repair mark - Yes / Front Bumper, Grille, Lamps - Scratch - Large / (L) Mirror - Scratch - Small / Trunk Hood, Rear Gate - Scratch - Minimal</p>
