## General Information

Date & Time: 07, Jun, 2025 16:01

<b>Make</b>	Mitsubishi	<b>Model</b>	Mirage
<b>YOM</b>	2022	<b>Odo Meter Reading</b>	33,608
<b>Registration No.</b>	NFJ9566	<b>Chassis No.</b>	PAEA13RJNMA023172
<b>CC</b>	1.2	<b>Transmission</b>	M/T
<b>Fuel Type</b>	Gas	<b>Type of Body</b>	Sedan
<b>Colour</b>	Silver

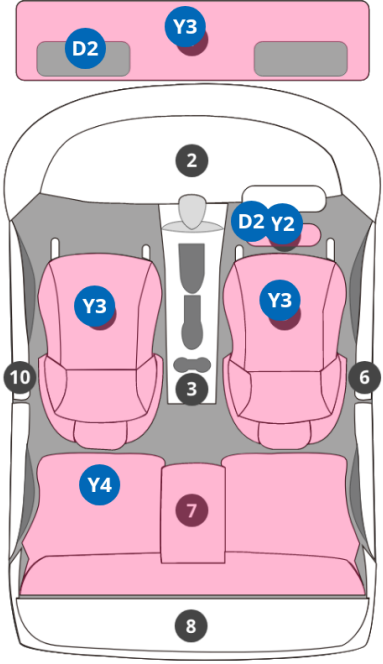
<b>Interior Evaluation :</b> <span style="float: right; color: red; font-weight: bold;">C</span>	<b>Exterior Evaluation :</b> <span style="float: right; color: red; font-weight: bold;">C</span>

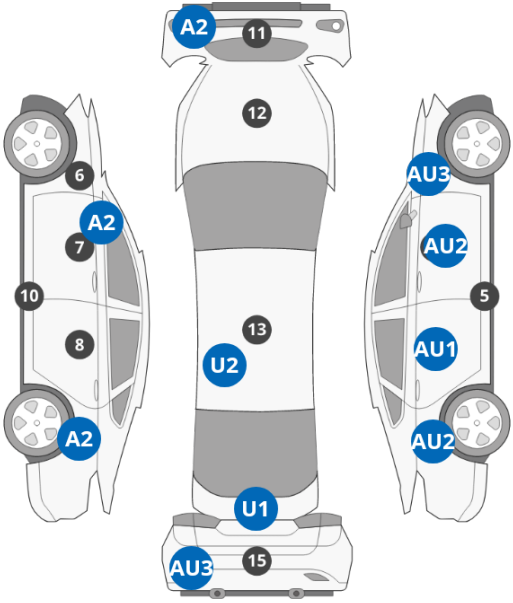
<p><b>A</b> : Scratch <b>AU</b> : Scratch &amp; Dent <b>B</b> : Modified <b>C</b> : Corrosion <b>G</b> : Stone chip <b>P</b> : Faded <b>S</b> : Rust <b>SC</b> : Rust &amp; Corrosion <b>U</b> : Dent <b>X</b> : Defective <b>Y</b> : Crack, Gap</p>
<p><b>Remarks</b> Ceiling - Grime - Medium / (R) Front Seat - Grime - Medium / Rear Seat - Grime - Large / Mat Other - Grime - Small / (L) Front Seat - Grime - Medium / (L) Front Floor Mat - Worked - Small / Sunvisor, Sunglass Holder - Crinkle - Small</p>	<p><b>Remarks</b> (R) Front Fender, Molding - Scratch &amp; Dent - Medium / (L) Mirror - Scratch - Small / Rear Bumper, Lamps, Panels - Scratch &amp; Dent - Medium / (R) Front Door, Molding - Scratch &amp; Dent - Small / (R) Rear Door, Molding - Scratch &amp; Dent - Minimal / (R) Rear Fender, Molding - Scratch &amp; Dent - Small / (L) Rear Fender, Molding - Scratch - Small / Trunk Hood, Rear Gate - Dent - Minimal / Front Bumper, Grille, Lamps - Scratch - Small / Roof - Dent - Small</p>
