## General Information

<b>Make</b>	Toyota	<b>Model</b>	Vios
<b>YOM</b>	2019	<b>Odo Meter Reading</b>	52,009
<b>Registration No.</b>	NBQ8310	<b>Chassis No.</b>	PA1B13F34K4080346
<b>CC</b>	1.3	<b>Transmission</b>	A/T
<b>Fuel Type</b>	Gas	<b>Type of Body</b>	Sedan
<b>Colour</b>	Blue

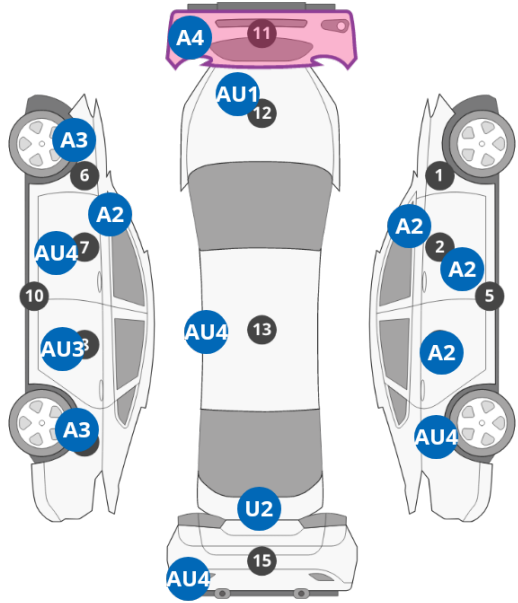
<p><b>A</b> : Scratch <b>AU</b> : Scratch &amp; Dent <b>B</b> : Modified <b>C</b> : Corrosion <b>G</b> : Stone chip <b>P</b> : Faded <b>S</b> : Rust <b>SC</b> : Rust &amp; Corrosion <b>U</b> : Dent <b>X</b> : Defective <b>Y</b> : Crack, Gap</p>
<p><b>Remarks</b> Ceiling - Grime - Medium / (R) Front Trim - Grime - Medium / (R) Front Seat - Grime - Medium / Rear Seat - Grime - Medium / (L) Front Trim - Grime - Medium / (L) Front Seat - Grime - Medium / Dashboard - Traces of Adhesive Tape - Yes</p>	<p><b>Remarks</b> (L) Rear Fender - Repair Traces - Yes / Front Bumper, Grille, Lamps - Scratch - Large / (L) Front Fender, Molding - Scratch - Medium / (L) Mirror - Scratch - Small / (L) Front Door, Molding - Scratch &amp; Dent - Large / (L) Rear Door, Molding - Scratch &amp; Dent - Medium / (L) Rear Fender, Molding - Scratch - Medium / Trunk Hood, Rear Gate - Dent - Small / (R) Rear Fender, Molding - Scratch &amp; Dent - Large / (R) Front Door, Molding - Scratch - Small / (R) Rear Door, Molding - Scratch - Small / (R) Mirror - Scratch - Small / Bonnet, Headlight - Scratch &amp; Dent - Minimal / Roof - Scratch &amp; Dent - Large / Rear Bumper, Lamps, Panels - Scratch &amp; Dent - Large / Front Bumper, Grille, Lamps - Repair mark - Yes</p>
