General Information

Make	Toyota	Model	Vios
YOM	2018	Odo Meter Reading	63,909
Registration No.	BAA2259	Chassis No.	PA1B19F34J4060843
CC	1.3	Transmission	M/T
Fuel Type	Gas	Type of Body	Sedan
Colour	Red Mica Metallic

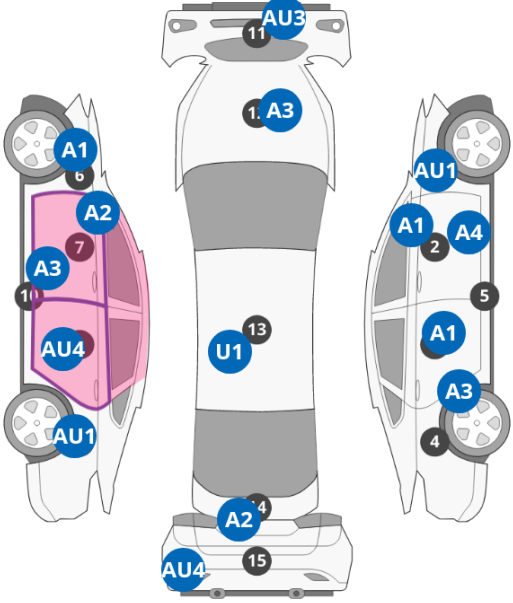
<p>A : Scratch AU : Scratch & Dent B : Modified C : Corrosion G : Stone chip P : Faded S : Rust SC : Rust & Corrosion U : Dent X : Defective Y : Crack, Gap</p>
<p>Remarks Ceiling - Grime - Large / (R) Front Seat - Grime - Medium / Rear Seat - Grime - Medium / (L) Front Seat - Grime - Medium / Carpet - Worked - Large</p>	<p>Remarks (L) Front Door - Repair Traces - Yes / (L) Rear Fender - Repair Traces - Yes / Trunk Hood, Rear Gate - Repair Traces - Yes / (R) Front Fender, Molding - Scratch & Dent - Minimal / (R) Front Door, Molding - Scratch - Large / (R) Rear Fender, Molding - Scratch - Medium / (R) Rear Door, Molding - Scratch - Minimal / Trunk Hood, Rear Gate - Scratch - Small / Rear Bumper, Lamps, Panels - Scratch & Dent - Large / (L) Rear Fender, Molding - Scratch & Dent - Minimal / (L) Mirror - Scratch - Small / (L) Front Door, Molding - Repair mark - Yes / (L) Rear Door, Molding - Repair mark - Yes / (L) Rear Door, Molding - Scratch & Dent - Large / (L) Front Door, Molding - Scratch - Medium / Front Bumper, Grille, Lamps - Scratch & Dent - Medium / Bonnet, Headlight - Scratch - Medium / (R) Mirror - Scratch - Minimal / (L) Front Fender, Molding - Scratch - Minimal / Roof - Dent - Minimal</p>
