## General Information

Date & Time: 09, Jun, 2025 08:56

<b>Make</b>	Toyota	<b>Model</b>	Avanza
<b>YOM</b>	2021	<b>Odo Meter Reading</b>	40,964
<b>Registration No.</b>	NGR8952	<b>Chassis No.</b>	MHKM5EE1FLK007124
<b>CC</b>	1.3	<b>Transmission</b>	M/T
<b>Fuel Type</b>	Gas	<b>Type of Body</b>	MPV
<b>Colour</b>	Gray

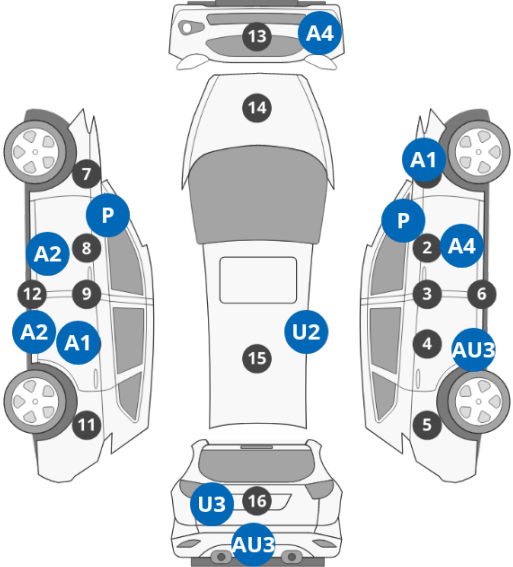
<p><b>A</b> : Scratch <b>AU</b> : Scratch &amp; Dent <b>B</b> : Modified <b>C</b> : Corrosion <b>G</b> : Stone chip <b>P</b> : Faded <b>S</b> : Rust <b>SC</b> : Rust &amp; Corrosion <b>U</b> : Dent <b>X</b> : Defective <b>Y</b> : Crack, Gap</p>
<p><b>Remarks</b>  (R) Front Floor Mat - Grime - Small / (R) Front Seat - Grime - Medium / Rear Seat - Grime - Medium / Ceiling - Grime - Small / Trunk Room - Loose, Deformed - Large / Mat Other - Grime - Small / (L) Front Seat - Grime - Medium / Console, Switchs, Vents - Worn, Scratch, Cut, Crack - Small</p>	<p><b>Remarks</b>  Bonnet - Repair Traces - Yes / Front Bumper, Grille, Lamps - Scratch - Large / (R) Mirror - Faded(Color, Gloss) - Yes / (L) Mirror - Faded(Color, Gloss) - Yes / (L) Front Door, Molding - Scratch - Small / (L) Step, In-panel, Side Spoiler - Scratch - Small / (L) Rear Door, Molding - Scratch - Minimal / (R) Front Fender, Molding - Scratch - Minimal / (R) Step, In-panel, Side Spoiler - Scratch &amp; Dent - Medium / (R) Front Door, Molding - Scratch - Large / Roof - Dent - Small / Trunk Hood, Rear Gate - Dent - Medium / Rear Bumper, Lamps, Panels - Scratch &amp; Dent - Medium</p>
