General Information

Make	Nissan	Model	NV350
YOM	2018	Odo Meter Reading	78,459
Registration No.	NBM6134	Chassis No.	JNT1C2E26Z0051226
CC	2.5	Transmission	M/T
Fuel Type	Diesel	Type of Body	Van
Colour	White

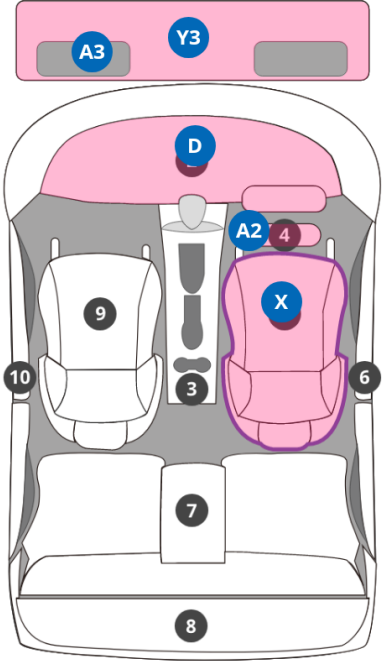
Interior Evaluation : C	Exterior Evaluation : D

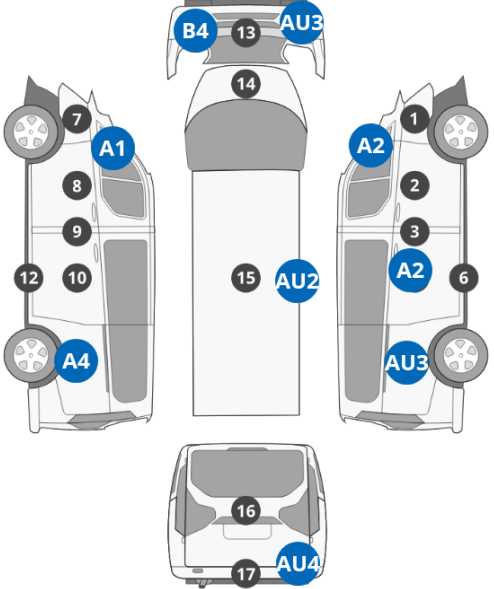
<p>A : Scratch AU : Scratch & Dent B : Modified C : Corrosion G : Stone chip P : Faded S : Rust SC : Rust & Corrosion U : Dent X : Defective Y : Crack, Gap</p>
<p>Remarks Ceiling - Grime - Medium / Dashboard - Traces of Adhesive Tape - Yes / (R) Front Seat - Partially Missing - Yes / (L) Front Floor Mat - Cut, Crack - Small / Sunvisor, Sunglass Holder - Cut, Crack - Medium</p>	<p>Remarks (R) Front Door - Repair Traces - Yes / Bonnet - Repair Traces - Yes / (L) Front Fender - Repair Traces - Yes / (L) Rear Fender - Repair Traces - Yes / Trunk Hood, Rear Gate - Repair Traces - Yes / (R) Rear Fender - Repair Traces - Yes / Roof - Repair Traces - Yes / (L) Rear Fender, Molding - Scratch - Large / Rear Bumper, Lamps, Panels - Scratch & Dent - Large / (R) Rear Fender, Molding - Scratch & Dent - Medium / (R) Rear Door, Molding - Scratch - Small / (R) Mirror - Scratch - Small / Front Bumper, Grille, Lamps - Modified - Large / (L) Mirror - Scratch - Minimal / Front Bumper, Grille, Lamps - Scratch & Dent - Medium / Roof - Scratch & Dent - Small</p>
