<b>Make</b>	Nissan	<b>Model</b>	NV350
<b>YOM</b>	2016	<b>Odo Meter Reading</b>	90,232
<b>Registration No.</b>	ACS1884	<b>Chassis No.</b>	JN1TC2E26Z0004898
<b>CC</b>	2.5	<b>Transmission</b>	M/T
<b>Fuel Type</b>	Diesel	<b>Type of Body</b>	Van
<b>Colour</b>	White

## Body / Panel Condition

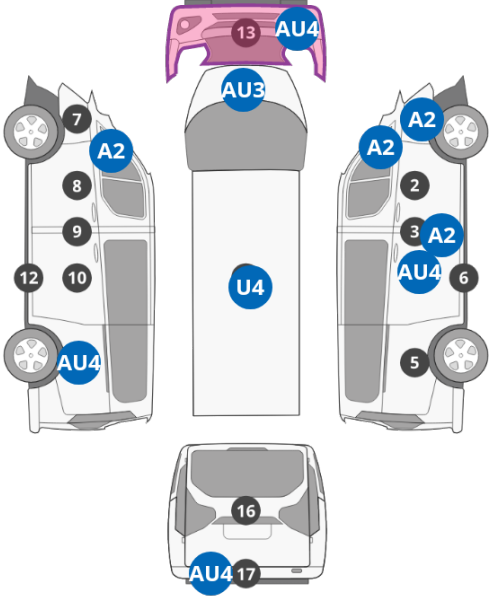
<p><b>A</b> : Scratch <b>AU</b> : Scratch &amp; Dent <b>B</b> : Modified <b>C</b> : Corrosion <b>G</b> : Stone chip <b>P</b> : Faded <b>S</b> : Rust <b>SC</b> : Rust &amp; Corrosion <b>U</b> : Dent <b>X</b> : Defective <b>Y</b> : Crack, Gap</p>
<p><b>Remarks</b> Overall Interior - Worn as per age - Yes / (R) Front Seat - Grime - Medium / Dashboard - Traces of Adhesive Tape - Yes / Ceiling - Grime - Large / Sunvisor, Sunglass Holder - Grime - Large / Room Lamp - Partially Missing - Yes / (L) Front Seat - Cut, Crack - Medium / Rear Seat - Partially Missing - Yes</p>	<p><b>Remarks</b> (R) Front Door - Repair Traces - Yes / (L) Front Door - Repair Traces - Yes / (L) Rear Fender - Repair Traces - Yes / (R) Rear Fender - Repair Traces - Yes / (R) Rear Door - Repair Traces - Yes / Roof - Repair Traces - Yes / (R) Rear Door, Molding - Scratch &amp; Dent - Large / Front Bumper, Grille, Lamps - Repair mark - Yes / Bonnet, Headlight - Scratch &amp; Dent - Medium / (R) Front Fender, Molding - Scratch - Small / (L) Mirror - Scratch - Small / (L) Rear Fender, Molding - Scratch &amp; Dent - Large / Rear Bumper, Lamps, Panels - Scratch &amp; Dent - Large / (R) Mirror - Scratch - Small / Front Bumper, Grille, Lamps - Scratch &amp; Dent - Large / (R) Center Panel - Scratch - Small / Roof - Dent - Large</p>
