## General Information

<b>Make</b>	Toyota	<b>Model</b>	Hiace
<b>YOM</b>	2025	<b>Odo Meter Reading</b>	3
<b>Registration No.</b>	DA602B	<b>Chassis No.</b>	JTFNAFAP9S8055396
<b>CC</b>	2.8	<b>Transmission</b>	M/T
<b>Fuel Type</b>	Diesel	<b>Type of Body</b>	Van
<b>Colour</b>	White

## Body / Panel Condition

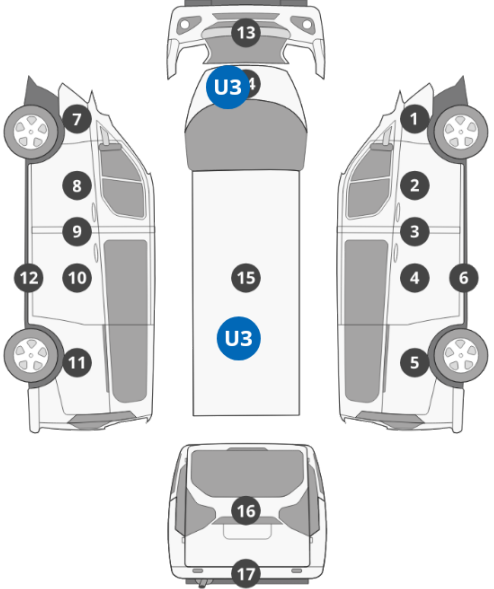
<b>Inspector Notes</b>
cluster of dents on roof and hood.
