## General Information

Date & Time: 20, Jun, 2025 11:03

<b>Make</b>	Toyota	<b>Model</b>	Vios
<b>YOM</b>	2024	<b>Odo Meter Reading</b>	34,412
<b>Registration No.</b>	NFR1257	<b>Chassis No.</b>	PA1B18F32R4247150
<b>CC</b>	1.3	<b>Transmission</b>	CVT
<b>Fuel Type</b>	Gas	<b>Type of Body</b>	Sedan
<b>Colour</b>	Silver

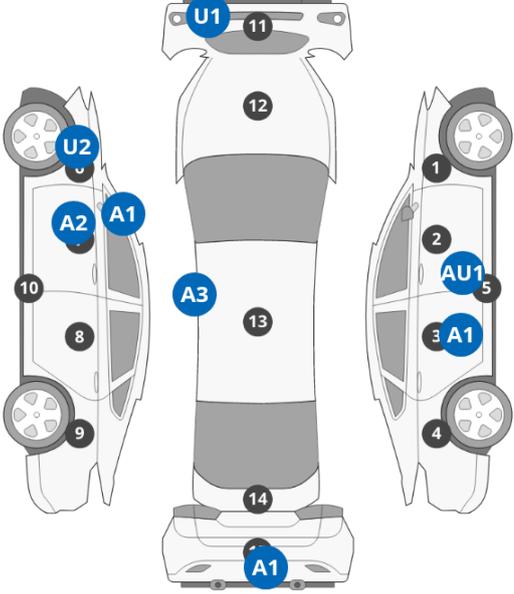
<p><b>A</b> : Scratch <b>AU</b> : Scratch &amp; Dent <b>B</b> : Modified <b>C</b> : Corrosion <b>G</b> : Stone chip <b>P</b> : Faded <b>S</b> : Rust <b>SC</b> : Rust &amp; Corrosion <b>U</b> : Dent <b>X</b> : Defective <b>Y</b> : Crack, Gap</p>
<p><b>Remarks</b> Mat Other - Missing - Yes / (L) Front Floor Mat - Cut, Crack - Medium / (R) Front Seat - Grime - Small / (L) Front Floor Mat - Worked - Large / Console, Switches, Vents - Traces of Adhesive Tape - Yes / Ceiling - Grime - Minimal</p>	<p><b>Remarks</b> (R) Front Door, Molding - Scratch &amp; Dent - Minimal / (R) Rear Door, Molding - Scratch - Minimal / Rear Bumper, Lamps, Panels - Scratch - Minimal / (L) Front Door, Molding - Scratch - Small / (L) Front Fender, Molding - Dent - Small / Front Bumper, Grille, Lamps - Dent - Minimal / (L) Mirror - Scratch - Minimal / Roof - Scratch - Medium</p>
