General Information

Make	Suzuki	Model	Dzire
YOM	2024	Odo Meter Reading	24,688
Registration No.	NKA6738	Chassis No.	MBHZF63S6RG478122
CC	1.2	Transmission	A/T
Fuel Type	Gas	Type of Body	Sedan
Colour	Red

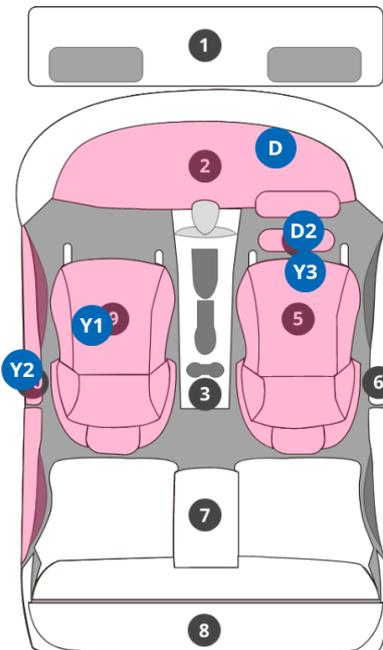
Interior Evaluation : B	Exterior Evaluation : D

<p>a : Cut, Fray d : Loose, Deformed k : Animal Hair s : Smell t : Cigarette Burns x : Defective y : Stain</p>

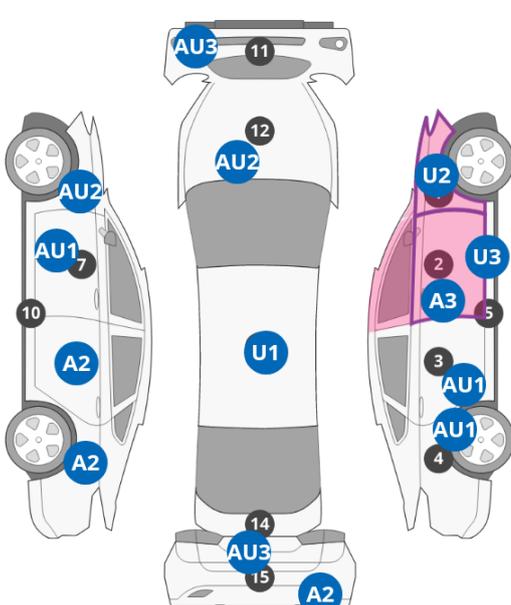
<p>A : Scratch AU : Scratch & Dent B : Modified C : Corrosion G : Stone chip P : Faded S : Rust SC : Rust & Corrosion U : Dent X : Defective Y : Crack, Gap</p>
<p>Remarks Dashboard - Traces of Adhesive Tape - Yes / (R) Front Seat - Grime - Medium / (L) Front Seat - Grime - Minimal / (L) Front Trim - Grime - Small / (L) Front Floor Mat - Worked - Small</p>	<p>Remarks (R) Front Door - Repair Traces - Yes / (R) Front Fender - Repair Traces - Yes / Front Bumper, Grille, Lamps - Scratch & Dent - Medium / (R) Front Fender, Molding - Repair mark - Yes / (R) Front Door, Molding - Repair mark - Yes / (L) Front Fender, Molding - Scratch & Dent - Small / (L) Front Door, Molding - Scratch & Dent - Minimal / (L) Rear Door, Molding - Scratch - Small / (L) Rear Fender, Molding - Scratch - Small / Trunk Hood, Rear Gate - Scratch & Dent - Medium / Rear Bumper, Lamps, Panels - Scratch - Small / (R) Rear Fender, Molding - Scratch & Dent - Minimal / (R) Rear Door, Molding - Scratch & Dent - Minimal / (R) Step, In-panel, Side Spoiler - Dent - Medium / (R) Front Fender, Molding - Dent - Small / Bonnet, Headlight - Scratch & Dent - Small / (R) Front Door, Molding - Scratch - Medium / Roof - Dent - Minimal</p>

<p>Inspector Notes</p>
<p>with LTO plate and Jack, Sparetire and incomplete tools. no warranty booklet, scratch headlight and crack and scratch tail lights.</p>
