## General Information

| Make | Toyota | Model | Vios |
| YOM | 2024 | Mileage | 6,336 |
| Registration No. | DBO1293 | Chassis No. | PA1B18F34P4236924 |

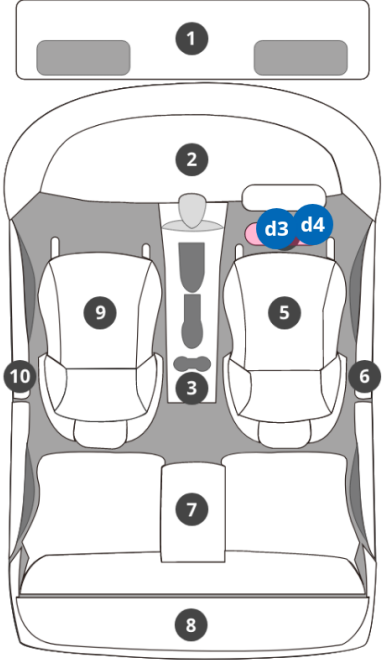
| Interior Evaluation : <b>C</b> | Exterior Evaluation : <b>A</b> |
|---|---|
| <b>Remarks</b><br>(L) Front Floor Lag - Loose, Deformed, Grime - Large / Lag Other - Loose, Deformed, Grime - Medium | <b>Remarks</b><br>(L) Front Fender - Repair Traces - Yes / (L) Front Door - Repair Traces - Yes / (L) Step - Repair Traces - Yes / (L) Rear Door - Repair Traces - Yes / (L) Rear Fender - Repair Traces - Yes / (R) Rear Fender, Molding - Scratch & Dent - Minimal / Front Bumper, Grille, Lamps - Scratch - Small |

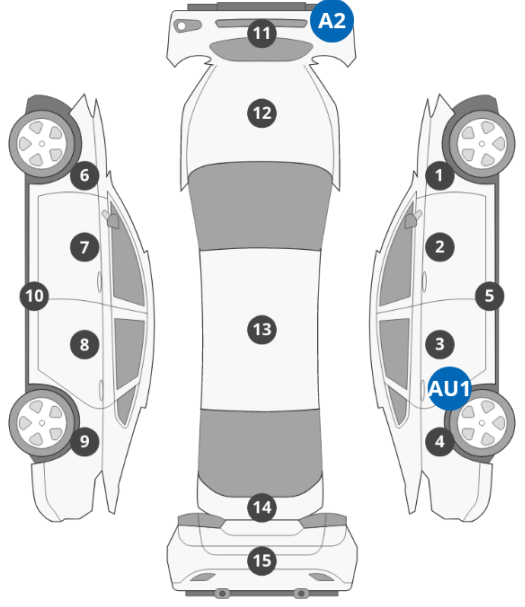
| Inspector Notes |
|---|
| signs of repair on the driver door, rear left door, rear left fender/no reverse camera/ no retractable mirror/ swirl marks and hairline scratches |
