## General Information

<b>Make</b>	Toyota	<b>Model</b>	Vios
<b>YOM</b>	2021	<b>Odo Meter Reading</b>	27,942
<b>Registration No.</b>	NFQ4359	<b>Chassis No.</b>	PA1B18F31L4129369
<b>CC</b>	1.3	<b>Transmission</b>	CVT
<b>Fuel Type</b>	Gas	<b>Type of Body</b>	Sedan
<b>Colour</b>	Green

## Body / Panel Condition

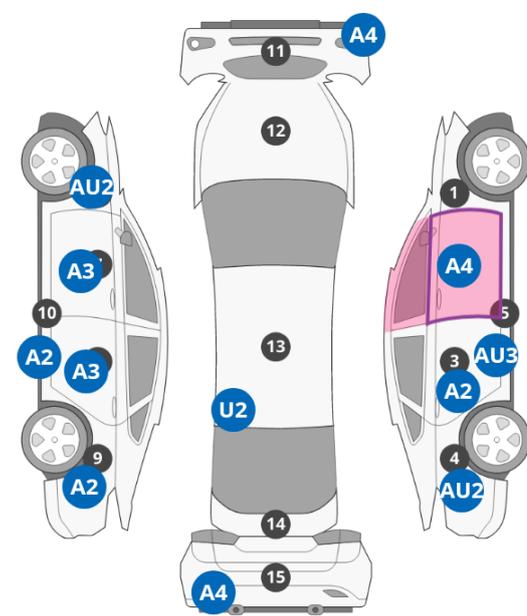
<p><b>A</b> : Scratch <b>AU</b> : Scratch &amp; Dent <b>B</b> : Modified <b>C</b> : Corrosion <b>G</b> : Stone chip <b>P</b> : Faded <b>S</b> : Rust <b>SC</b> : Rust &amp; Corrosion <b>U</b> : Dent <b>X</b> : Defective <b>Y</b> : Crack, Gap</p>
<p><b>Remarks</b> Dashboard - Traces of Adhesive Tape - Yes / (R) Front Trim - Grime - Minimal / Rear Seat - Grime - Small / Trunk Room - Worn, Scratch, Cut, Crack - Minimal / (L) Front Floor Mat - Grime - Medium / Ceiling - Grime - Small / (L) Front Trim - Grime - Medium / Steering Wheel - Worn, Peel, Crack - Large</p>	<p><b>Remarks</b> (R) Front Door - Repair Traces - Yes / (R) Front Door, Molding - Repair mark - Yes / (R) Front Door, Molding - Scratch - Large / (R) Step, In-panel, Side Spoiler - Scratch &amp; Dent - Medium / (R) Rear Door, Molding - Scratch - Small / (R) Rear Fender, Molding - Scratch &amp; Dent - Small / Rear Bumper, Lamps, Panels - Scratch - Large / (L) Rear Fender, Molding - Scratch - Small / (L) Rear Door, Molding - Scratch - Medium / (L) Step, In-panel, Side Spoiler - Scratch - Small / (L) Front Door, Molding - Scratch - Medium / (L) Front Fender, Molding - Scratch &amp; Dent - Small / Front Bumper, Grille, Lamps - Scratch - Large / Roof - Dent - Small</p>
