## General Information

<b>Make</b>	Toyota	<b>Model</b>	Fortuner
<b>YOM</b>	2017	<b>Odo Meter Reading</b>	43,136
<b>Registration No.</b>	NDD3732	<b>Chassis No.</b>	MHFGB8GS3G0820277
<b>CC</b>	2.4	<b>Transmission</b>	A/T
<b>Fuel Type</b>	Diesel	<b>Type of Body</b>	SUV
<b>Colour</b>	Gray

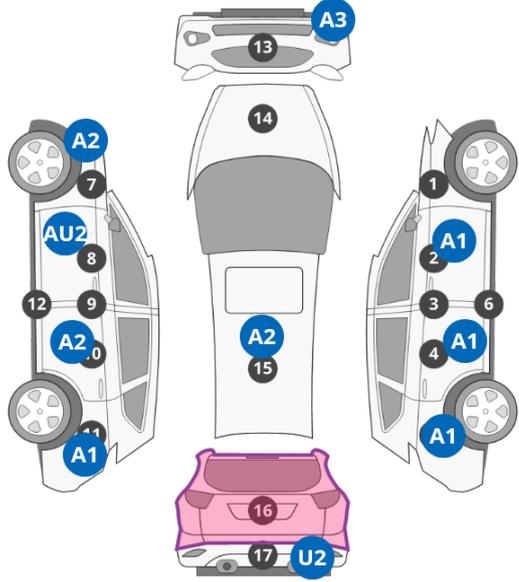
<p><b>A</b> : Scratch <b>AU</b> : Scratch &amp; Dent <b>B</b> : Modified <b>C</b> : Corrosion <b>G</b> : Stone chip <b>P</b> : Faded <b>S</b> : Rust <b>SC</b> : Rust &amp; Corrosion <b>U</b> : Dent <b>X</b> : Defective <b>Y</b> : Crack, Gap</p>
<p><b>Remarks</b> (L) Front Floor Mat - Grime - Small / Ceiling - Grime - Small / Rear Seat - Grime - Small</p>	<p><b>Remarks</b> Trunk Hood, Rear Gate - Repair Traces - Yes / Roof - Repair Traces - Yes / Trunk Hood, Rear Gate - Repair mark - Yes / Rear Bumper, Lamps, Panels - Dent - Small / (R) Rear Fender, Molding - Scratch - Minimal / (R) Rear Door, Molding - Scratch - Minimal / Front Bumper, Grille, Lamps - Scratch - Medium / (L) Front Fender, Molding - Scratch - Small / (L) Front Door, Molding - Scratch &amp; Dent - Small / (L) Rear Door, Molding - Scratch - Small / (L) Rear Fender, Molding - Scratch - Minimal / (R) Front Door, Molding - Scratch - Minimal / Roof - Scratch - Small</p>
