## General Information

| Make | Toyota | Model | Vios |
| YOM | 2016 | Odo Meter Reading | 392,250 |
| Registration No. | ABQ3358 | Chassis No. | NCP1512053304 |

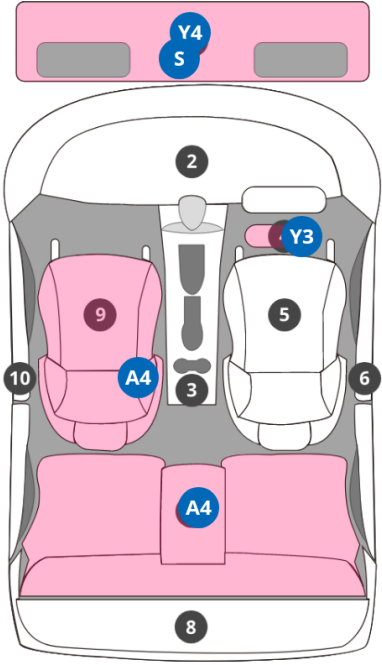
| Interior Evaluation : <span style="color: red; font-weight: bold;">A</span> | Exterior Evaluation : <span style="color: red; font-weight: bold;">E</span> |
|---|---|
| <p><b>Remarks</b></p> <p>Ceiling - Grime - Large / (R) Front Floor Mat - Grime - Medium / Rear Seat - Cut, Crack - Large / (L) Front Seat - Cut, Crack - Large / Overall Interior - Smell - Yes</p> | <p><b>Remarks</b></p> <p>(R) Front Door - Repair Traces - Yes / (R) Step - Repair Traces - Yes / (R) Front Fender - Repair Traces - Yes / Bonnet - Repair Traces - Yes / (L) Front Fender - Repair Traces - Yes / (L) Front Door - Repair Traces - Yes / (L) Step - Repair Traces - Yes / (L) Rear Door - Repair Traces - Yes / (L) Rear Fender - Repair Traces - Yes / Trunk Hood, Rear Gate - Repair Traces - Yes / (R) Rear Fender - Repair Traces - Yes / (R) Rear Door - Repair Traces - Yes / Roof - Repair Traces - Yes / (R) Front Door, Molding - Scratch &amp; Dent - Large / (R) Rear Door, Molding - Scratch - Medium / (R) Front Fender, Molding - Scratch &amp; Dent - Small / (R) Mirror - Scratch - Small / (L) Front Door, Molding - Scratch - Medium / (L) Rear Door, Molding - Scratch - Medium / (L) Rear Fender, Molding - Scratch &amp; Dent - Small / Rear Bumper, Lamps, Panels - Scratch - Medium / (R) Rear Fender, Molding - Scratch - Medium / Front Bumper, Grille, Lamps - Repair mark - Yes / Front Bumper, Grille, Lamps - Scratch - Small / (L) Front Fender, Molding - Scratch - Small / Bonnet, Headlight - Repair mark - Yes / (L) Mirror - Scratch - Minimal / Trunk Hood, Rear Gate - Scratch &amp; Dent - Minimal</p> |
