## General Information

| Make | Toyota | Model | Innova |
| Registration No. | DAZ5554 | Chassis No. | PA2CA8EM7K0071269 |

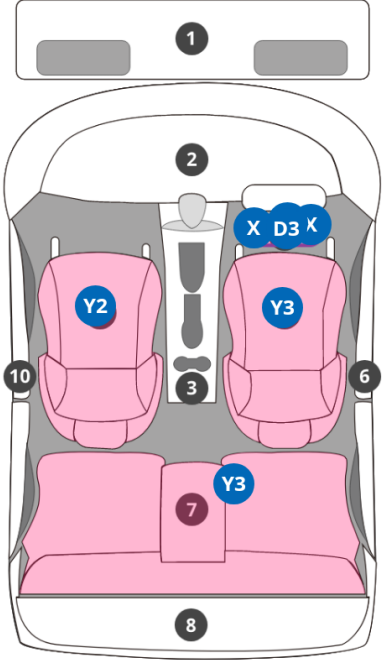
| <b>Interior Evaluation :</b> <b>B</b> | <b>Exterior Evaluation :</b> <b>E</b> |
| <b>Remarks</b><br>(R) Front Floor Mat - Missing - Yes / Mat Other - Missing - Yes / (L) Front Floor Mat - Missing - Yes / (R) Front Seat - Grime - Medium / Rear Seat - Grime - Medium / Carpet - Loose, Deformed - Medium / (L) Front Seat - Grime - Small | <b>Remarks</b><br>Trunk Hood, Rear Gate - Repair Traces - Yes / (R) Rear Door - Repair Traces - Yes / Trunk Hood, Rear Gate - Repair mark - Yes / (L) Mirror - Scratch - Medium / (L) Front Door, Molding - Scratch & Dent - Large / (L) Rear Door, Molding - Scratch & Dent - Medium / Bonnet, Headlight - Dent - Small / Front Bumper, Grille, Lamps - Scratch & Dent - Large / (R) Front Fender, Molding - Scratch & Dent - Medium / (R) Mirror - Scratch - Small / (R) Rear Door, Molding - Scratch & Dent - Large / (R) Front Door, Molding - Scratch - Small / (R) Rear Fender, Molding - Scratch - Large / Rear Bumper, Lamps, Panels - Scratch & Dent - Large / (L) Rear Fender, Molding - Scratch & Dent - Small / Trunk Hood, Rear Gate - Dent - Large |
