## General Information

<b>Make</b>	Toyota	<b>Model</b>	Veloz
<b>YOM</b>	2024	<b>Mileage</b>	7,286
<b>Registration No.</b>	EAJ1247	<b>Chassis No.</b>	MHFAB1BY3P3069284
<b>CC</b>	1.5	<b>Transmission</b>	CVT
<b>Fuel Type</b>	Gas	<b>Type of Body</b>	SUV
<b>Colour</b>	Purple

## Body / Panel Condition

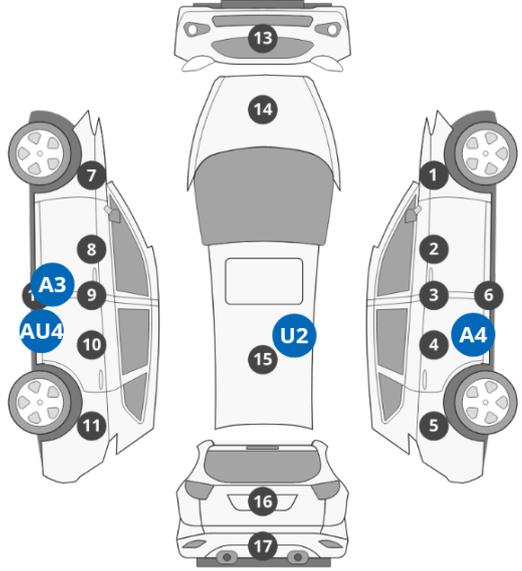
<p><b>A</b> : Scratch <b>AU</b> : Scratch &amp; Dent <b>B</b> : Modified <b>C</b> : Corrosion <b>G</b> : Stone chip <b>P</b> : Faded <b>S</b> : Rust <b>SC</b> : Rust &amp; Corrosion <b>U</b> : Dent <b>X</b> : Defective <b>Y</b> : Crack, Gap</p>
<p><b>Remarks</b> Dashboard - Traces of Adhesive Tape - Yes</p>	<p><b>Remarks</b> (L) Front Door, Molding - Scratch - Medium / (L) Rear Door, Molding - Scratch &amp; Dent - Large / (R) Rear Door, Molding - Scratch - Large / Roof - Dent - Small</p>
<b>Frame Evaluation :</b> <span style="color: red; font-weight: bold; font-size: 1.2em;">A</span>	<b>Functional Evaluation :</b> <span style="color: red; font-weight: bold; font-size: 1.2em;">A</span>

<p><b>Inspector Notes</b></p>
<p>swirl marks and hairline scratches present/ good condition</p>
