## General Information

| Make | Toyota | Model | Vios |
| YOM | 2025 | Odo Meter Reading | 9,555 |
| Registration No. | NHS3158 | Chassis No. | PA1B18F32R4261758 |

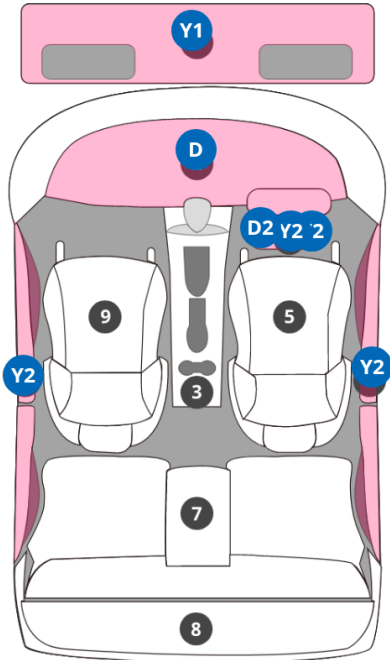
| <b>Remarks</b><br>Ceiling - Grime - Minimal / (R) Front Trim - Grime - Small / (R) Front Floor Mat - Grime - Small / Mat Other - Grime - Small / (L) Front Trim - Grime - Small / (L) Front Floor Mat - Worked - Small / Dashboard - Traces of Adhesive Tape - Yes | <b>Remarks</b><br>(R) Front Fender - Repair Traces - Yes / (L) Front Fender - Repair Traces - Yes / Front Bumper, Grille, Lamps - Repair mark - Yes / (L) Front Fender, Molding - Repair mark - Yes / (R) Front Fender, Molding - Repair mark - Yes / Member (Bolted) - Dent - Yes / (L) Mirror - Crack - Damaged / (L) Front Door, Molding - Scratch - Small / (R) Front Door, Molding - Scratch & Dent - Minimal / (R) Step, In-panel, Side Spoiler - Scratch - Small / (R) Rear Fender, Molding - Scratch - Small / Rear Bumper, Lamps, Panels - Scratch - Medium / Front Bumper, Grille, Lamps - Scratch & Dent - Large / (L) Front Fender, Molding - Dent - Medium / (R) Front Fender, Molding - Dent - Large / Overall Exterior - Re-Paint Uneven - Yes |
