## General Information

| Make | Toyota | Model | Hiace |
| Registration No. | CBT3253 | Chassis No. | JTFJT02PXN5033031 |

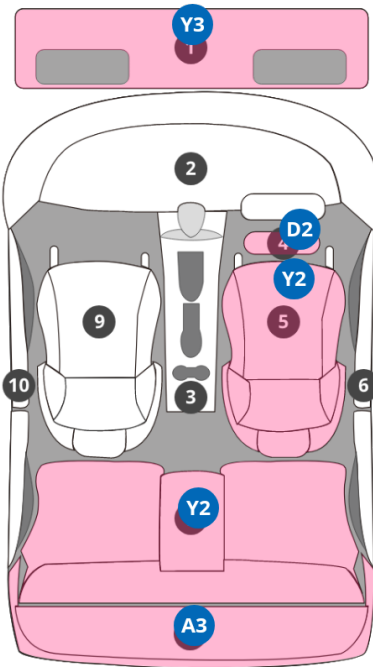
| Interior Evaluation : <span style="color: red; font-weight: bold;">C</span> | | Exterior Evaluation : <span style="color: red; font-weight: bold;">E</span> | |
| <p><b>Remarks</b></p> <p>Trunk Room - Worn, Scratch, Cut, Crack - Medium / Ceiling - Grime - Medium / Rear Seat - Grime - Small / (R) Front Seat - Grime - Small / (L) Front Floor Mat - Worked - Small / Overall Interior - Worn as per age - Yes</p> | | <p><b>Remarks</b></p> <p>Front Panel - Repair Traces - Yes / Trunk Hood, Rear Gate - Repair Traces - Yes / (R) Rear Fender - Repair Traces - Yes / Front Panel - Repair mark - Yes / (R) Rear Fender, Molding - Repair mark - Yes / Trunk Hood, Rear Gate - Repair mark - Yes / (R) Front Door, Molding - Modified - Large / (R) Center Panel - Modified - Medium / (R) Rear Door, Molding - Scratch &amp; Dent - Small / (R) Rear Fender, Molding - Modified - Large / Trunk Hood, Rear Gate - Dent - Medium / Rear Bumper, Lamps, Panels - Scratch - Small / (L) Rear Fender, Molding - Modified - Large / (L) Rear Door, Molding - Scratch &amp; Dent - Small / (L) Front Door, Molding - Modified - Medium / Front Bumper, Grille, Lamps - Modified - Large / Front Panel - Scratch &amp; Dent - Minimal / Roof - Scratch &amp; Dent - Minimal / (L) Front Fender, Molding - Scratch - Minimal / (R) Front Fender, Molding - Scratch - Small / (R) Mirror - Scratch - Minimal / (L) Mirror - Scratch - Minimal</p> | |

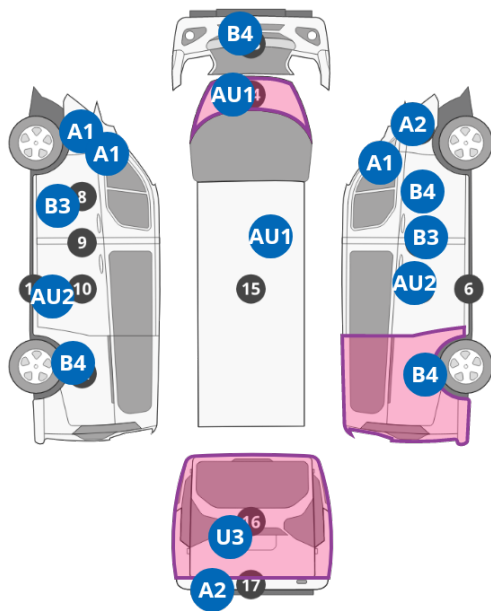
with LTO plate, no warranty booklet, no jack and tools, with spare tire, cracked tail light, traces of adhesive on front pillar and roof
