## General Information

| Make | Suzuki | Model | Carry |
| Registration No. | NHB5528 | Chassis No. | MHYDC61T6PJ210218 |

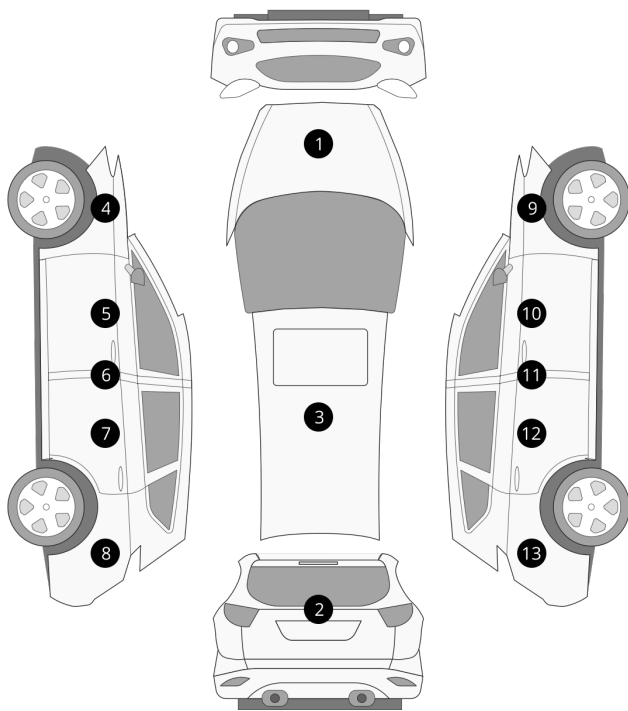
| # | Area | Thickness(um) | | | |
| 8 | Left Back Panel | 204.0 | 183 | 258 | 171 |
| 13 | Right Back Panel | 154.3 | 128 | 167 | 168 |

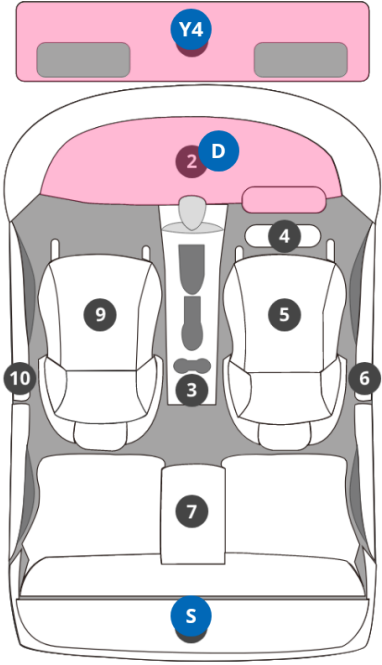
| Interior Evaluation : <b>C</b> | Exterior Evaluation : <b>E</b> |
| <b>Remarks</b><br>Overall Interior - Worn as per age - Yes / Overall Interior - Smell - Yes / Dashboard - Traces of Adhesive Tape - Yes / Ceiling - Grime - Large | <b>Remarks</b><br>(L) Rear Corner Panel - Repair Traces - Yes / (R) Front Door, Molding - Scratch - Medium / (R) Center Panel - Scratch - Small / (R) Front Fender, Molding - Scratch - Minimal / (R) Mirror - Scratch - Minimal / (R) Side Gate - Scratch & Dent - Large / Rear Bumper, Lamps, Panels - Crack, Gap - Medium / Rear Gate - Modified - Small / Rear Gate - Scratch - Medium / Cargo Bed Floor - Scratch - Large / (L) Side Gate - Scratch & Dent - Large / (L) Center Panel - Scratch - Small / (L) Front Door, Molding - Scratch - Small / (L) Mirror - Scratch - Small / Front Bumper, Grille, Lamps - Scratch - Large / Roof - Scratch - Small / Front Panel - Scratch & Dent - Small |
