## General Information

| Make | Suzuki | Model | APV |
| Registration No. | NKD6333 | Chassis No. | MHYDN71V6RJ402162 |

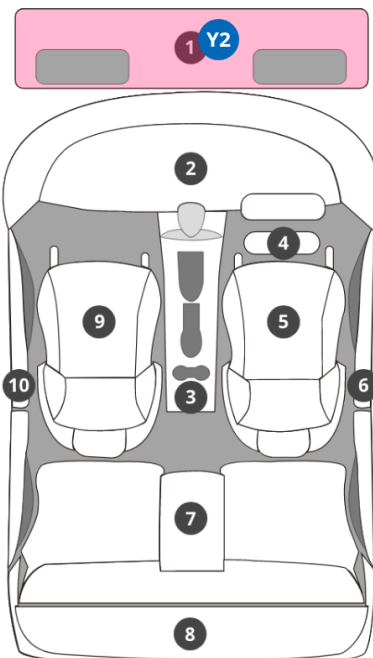
| Interior Evaluation : <span style="color: red; font-weight: bold;">A</span> | Exterior Evaluation : <span style="color: red; font-weight: bold;">B</span> |
|---|---|
| <p><b>Remarks</b></p> <p>Ceiling - Grime - Small</p> | <p><b>Remarks</b></p> <p>(R) Front Door, Molding - Scratch - Small / (R) Rear Door, Molding - Scratch - Minimal / (R) Rear Fender, Molding - Scratch - Small / Trunk Hood, Rear Gate - Scratch - Minimal / Rear Bumper, Lamps, Panels - Scratch - Minimal / (L) Rear Fender, Molding - Scratch - Minimal / (L) Rear Door, Molding - Scratch - Minimal / (L) Front Door, Molding - Scratch - Minimal / (L) Front Fender, Molding - Scratch - Minimal / Front Bumper, Grille, Lamps - Scratch - Minimal / Roof - Scratch - Minimal / Front Panel - Scratch - Minimal</p> |
