## General Information

| Make | Toyota | Model | Vios |
| Registration No. | EAF3809 | Chassis No. | PA1B18F32N4181175 |

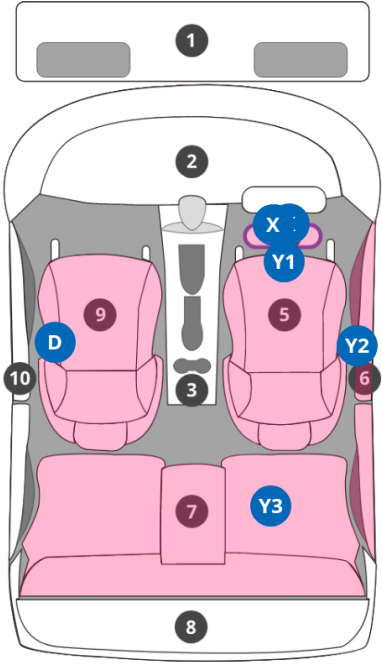
| Interior Evaluation : <b>B</b> | Exterior Evaluation : <b>C</b> |
| <p><b>Remarks</b></p> <p>Rear Seat - Grime - Medium / (R) Front Trim - Grime - Small / (R) Front Seat - Grime - Minimal / (L) Front Seat - Worn - Yes / Mat Other - Missing - Yes / (R) Front Floor Mat - Missing - Yes / (L) Front Floor Mat - Missing - Yes</p> | <p><b>Remarks</b></p> <p>(R) Mirror - Scratch - Minimal / (R) Front Fender, Molding - Scratch &amp; Dent - Small / (R) Front Door, Molding - Scratch - Small / (R) Rear Door, Molding - Scratch &amp; Dent - Medium / (R) Rear Fender, Molding - Scratch &amp; Dent - Small / Rear Bumper, Lamps, Panels - Scratch - Small / (L) Rear Fender, Molding - Scratch - Small / (L) Front Door, Molding - Scratch - Small / (L) Rear Door, Molding - Scratch &amp; Dent - Small / (L) Front Fender, Molding - Scratch - Minimal / Front Bumper, Grille, Lamps - Scratch - Minimal / Bonnet, Headlight - Scratch - Minimal / Roof - Scratch - Minimal</p> |
